Rescue, research and reconstruction at Lewes Castle 2019 – 2022

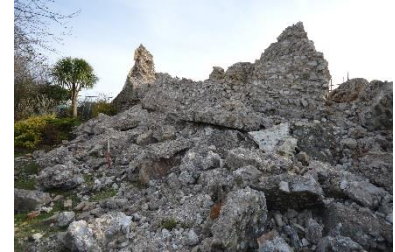
On the 11th November 2019 a section of the Scheduled curtain wall at Lewes Castle suffered a catastrophic collapse, resulting in extensive property damage and the loss of a significant section of the surviving defences of an early and important castle.

View of the wall after the collapse

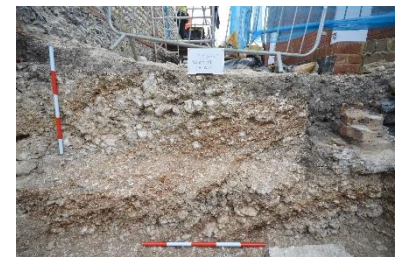
In archaeological terms, our work has shown that the curtain wall formed just one component of the southern defences of the castle, along with a massive defensive bank and ditch that was created in the immediate post-conquest period. The wall itself was of mass construction built atop the pre-existing defensive bank. As first built, it consisted of a core of mortared chalk rubble, supported on a shallow raft or layer of chalk and clay, and encased in a facing that has long-since been replaced through centuries of maintenance and repair.

Section through the defensive bank beneath the wall

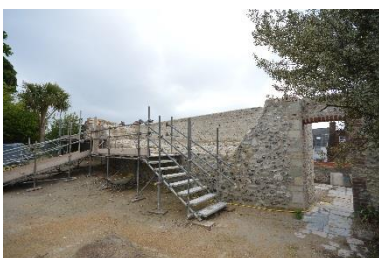
Reconstruction work nearing completion

In light of these findings, full reconstruction of the wall to its former height was not considered viable. Instead, reinstatement has focussed on establishing a balance between stabilising and protecting what remains of the wall and its associated archaeological evidence whilst meeting the needs of the landowners whose lives and property have been so profoundly affected by the collapse. At the same time, we hope to use the results of our work to inform on the future management of similar monuments elsewhere, so we can better adapt and protect our unique heritage to our ever changing climate.
