ASSOCIATION FOR STUDIES IN THE CONSERVATION OF HISTORIC BUILDINGS

ASCHB TRANSACTIONS VOLUME 39: 2017

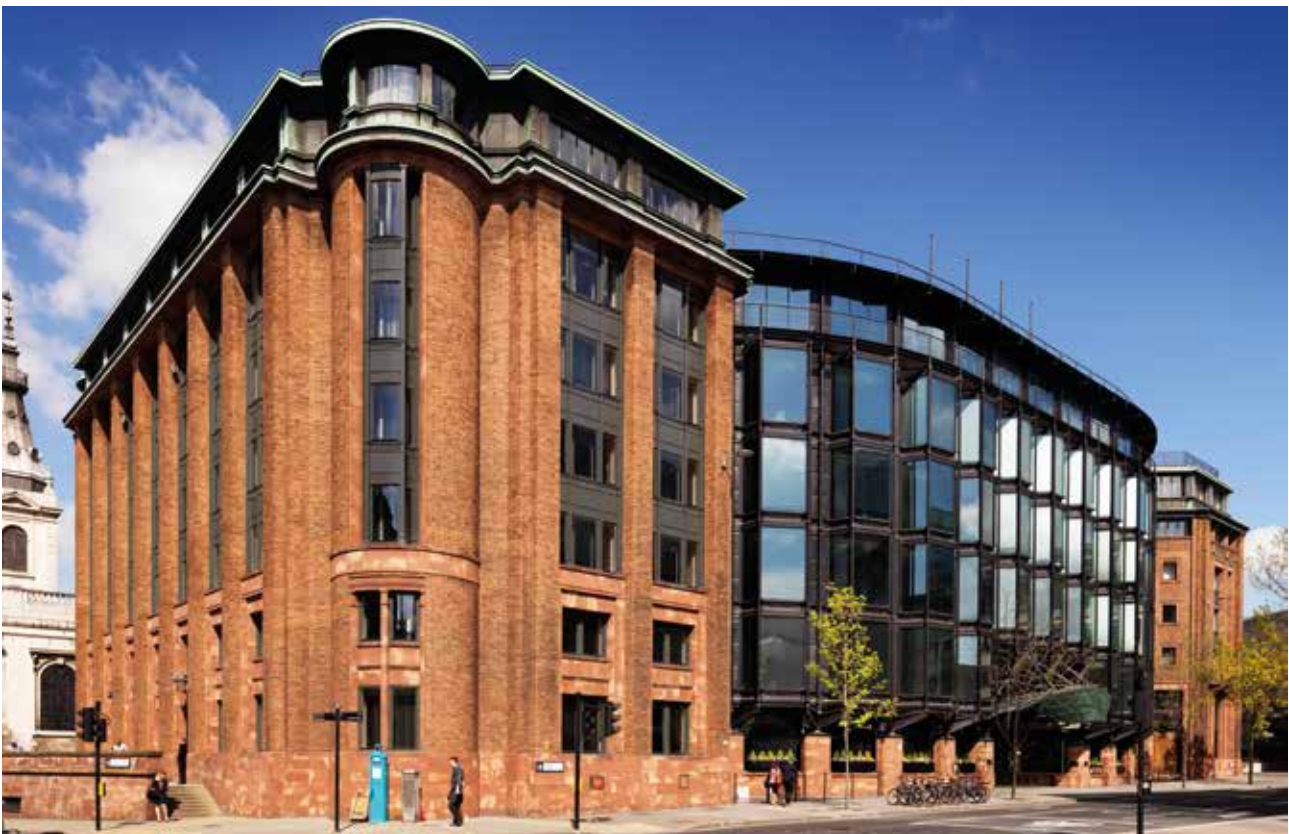
Fig 1 Bracken House, Friday Street, City of London, 1955–59

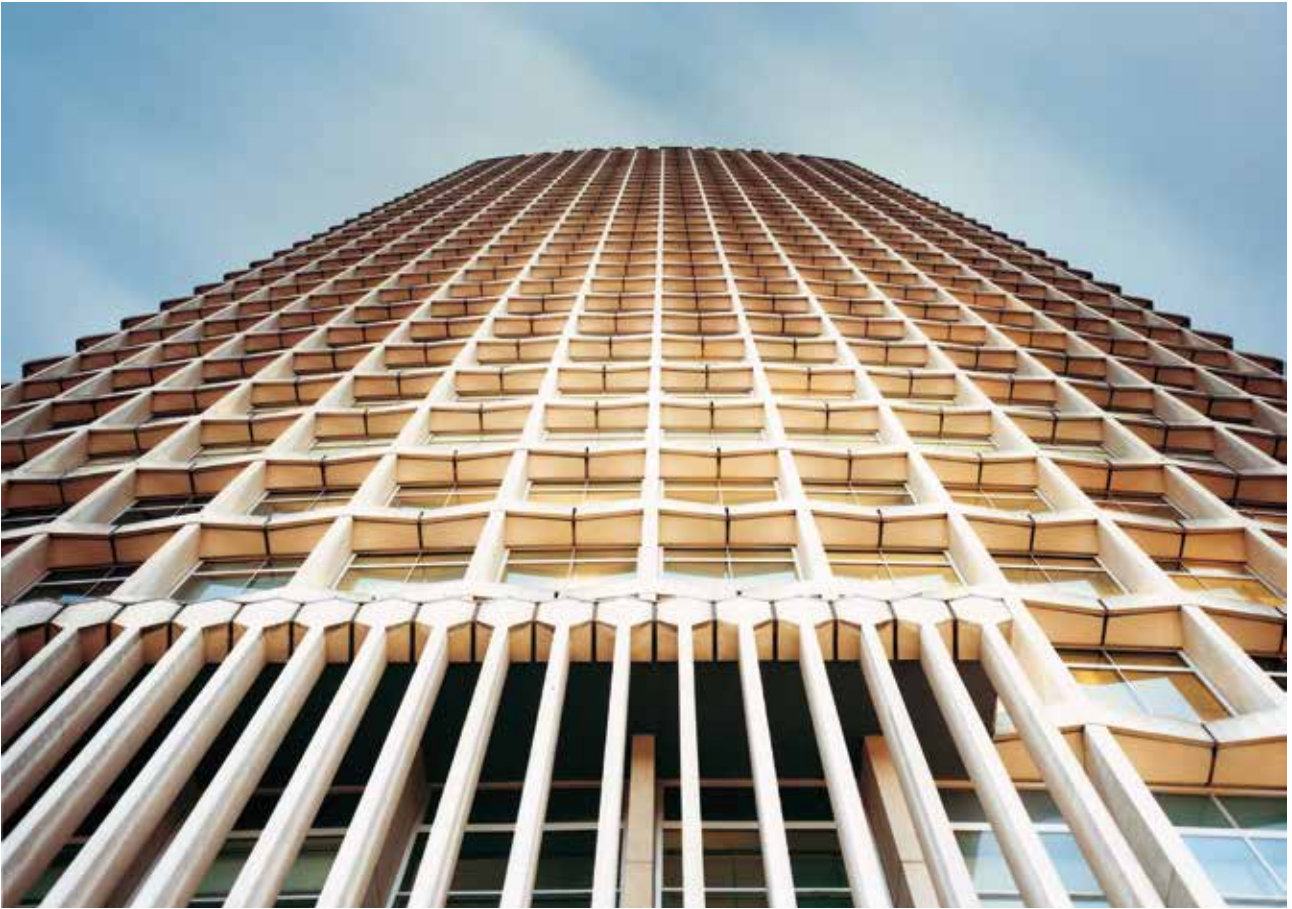
Fig 2 Centre Point, New Oxford Street, London Borough of Camden, 1961–66

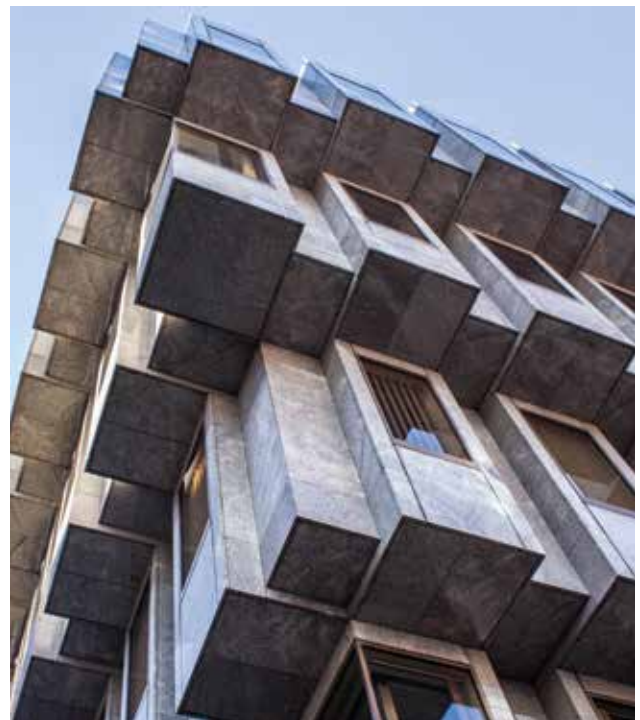
Fig 5 Bank House, King Street, Leeds, 1969–71

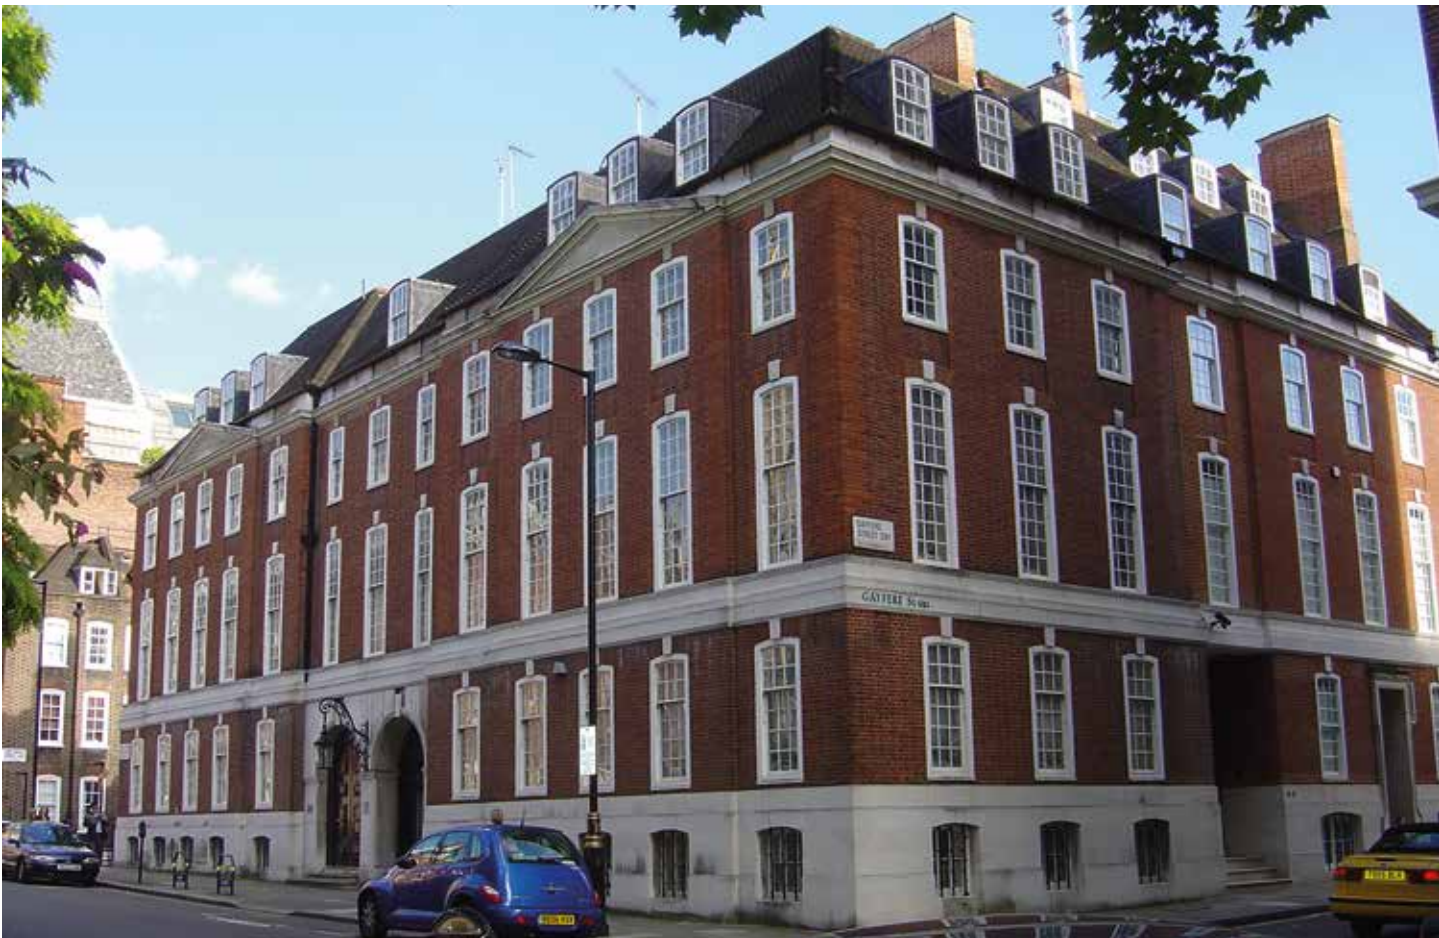
Fig 6 North House and Gayfere House, Gayfere Street, London

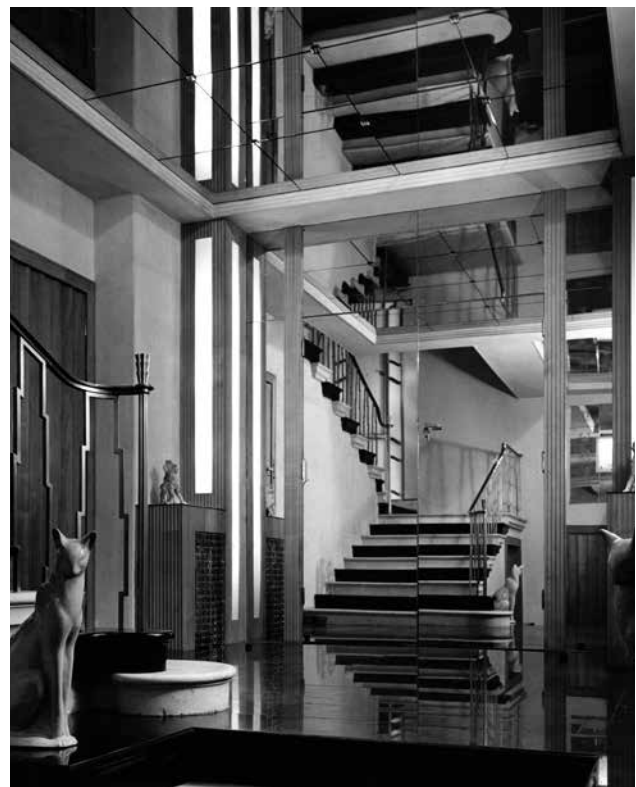
Fig 7 Gayfere House, entrance hall, 1931

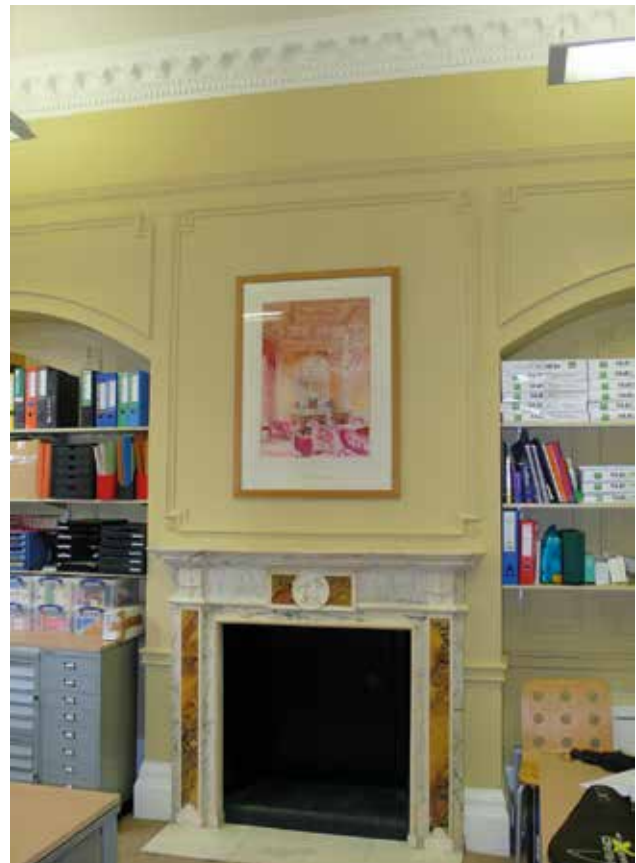
Fig 8 No 12 Devonshire Street, London, front room

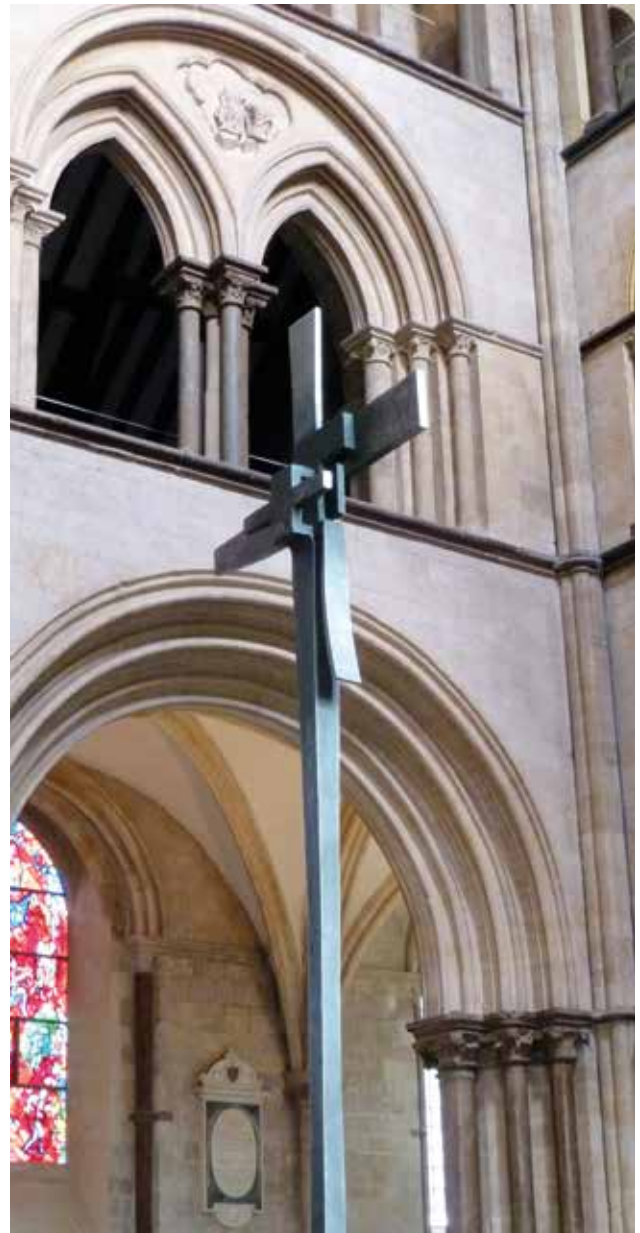
Fig 1 New cross (2010) by Jonathan Clarke at the shrine in Chichester Cathedral

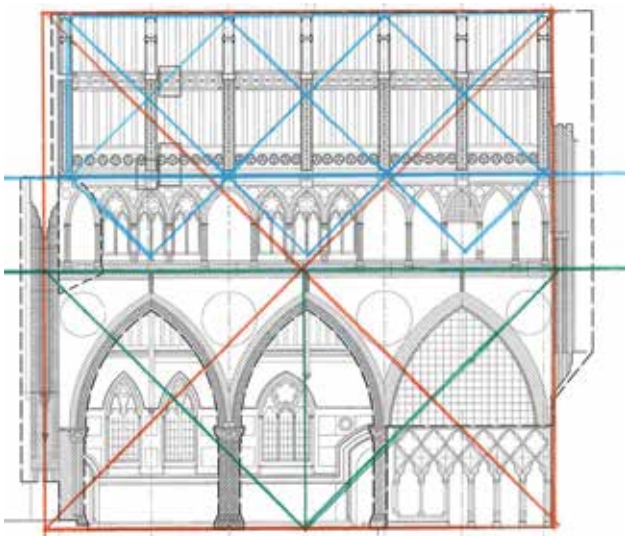
Fig 4 William Butterfield's All Saints, Margaret Street, London: long section of the nave, a virtual cube room equal in width, length and height

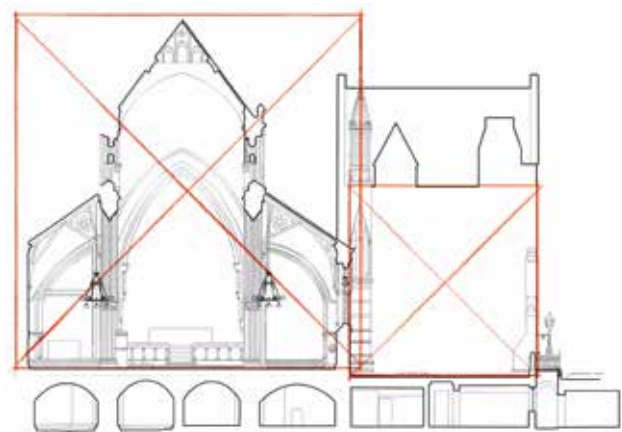
Fig 5 All Saints, Margaret Street: the ordering proportion principle extends to the house elevation

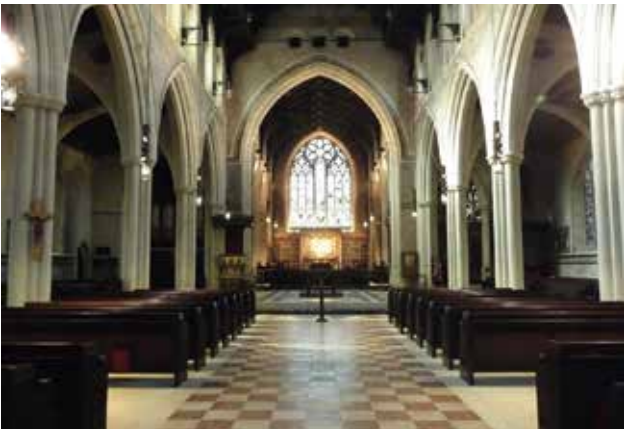
Fig 13 St James's, Sussex Gardens: reordered with adherence to GE Street's proportional discipline

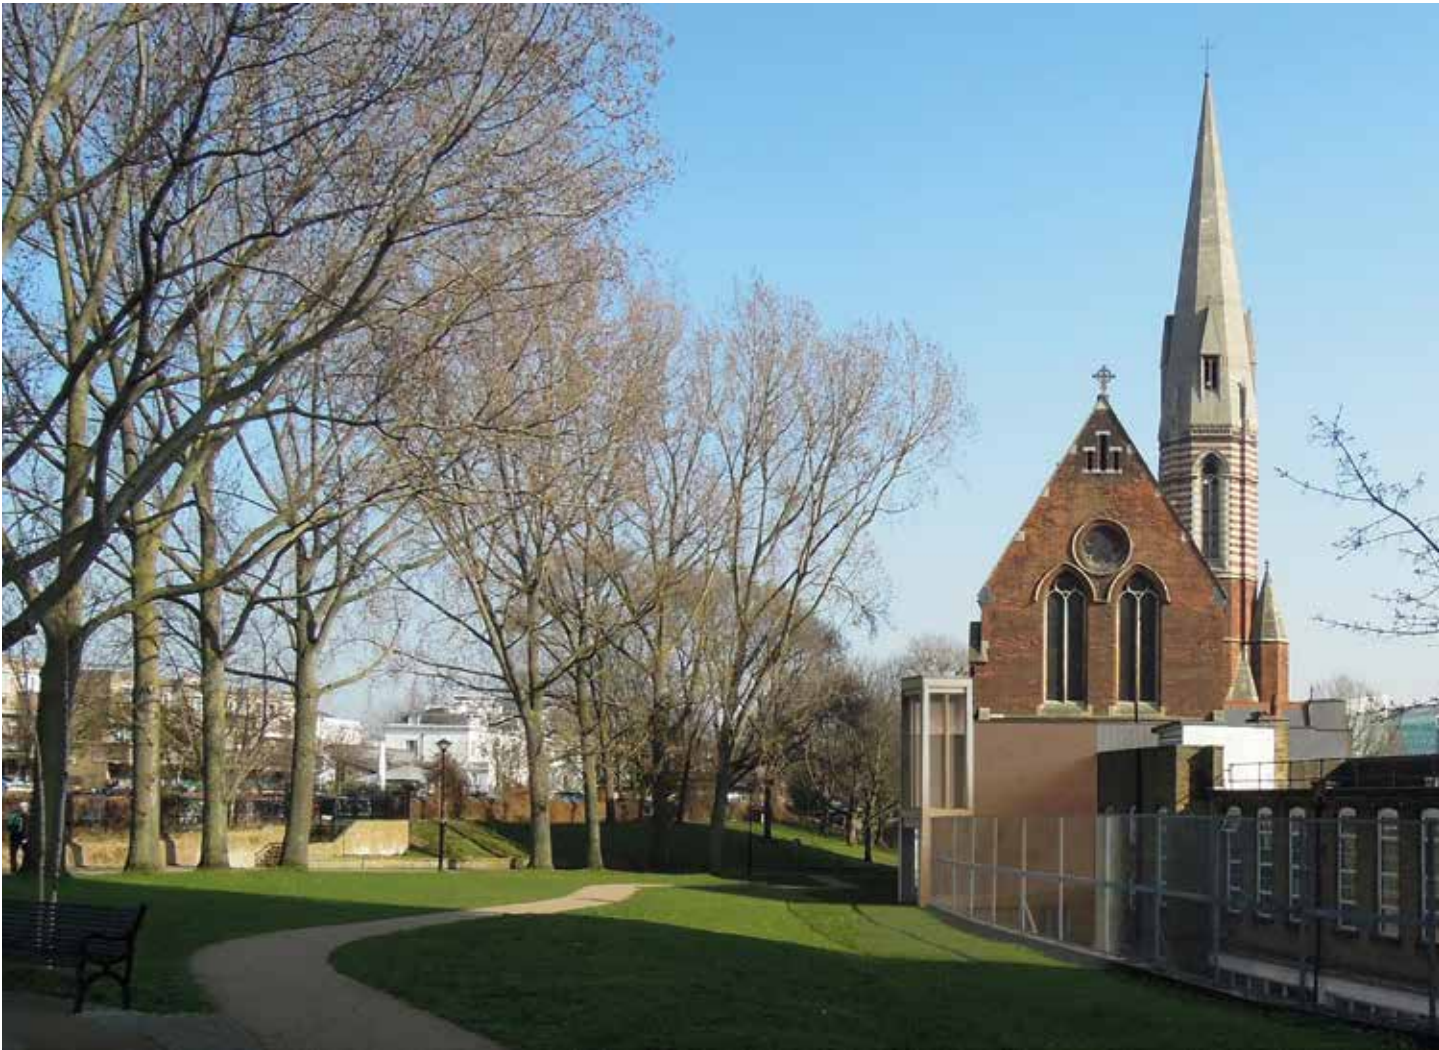
Fig 18 Dow Jones' carefully proportioned scheme for St Mary Magdalene, Paddington, from the west

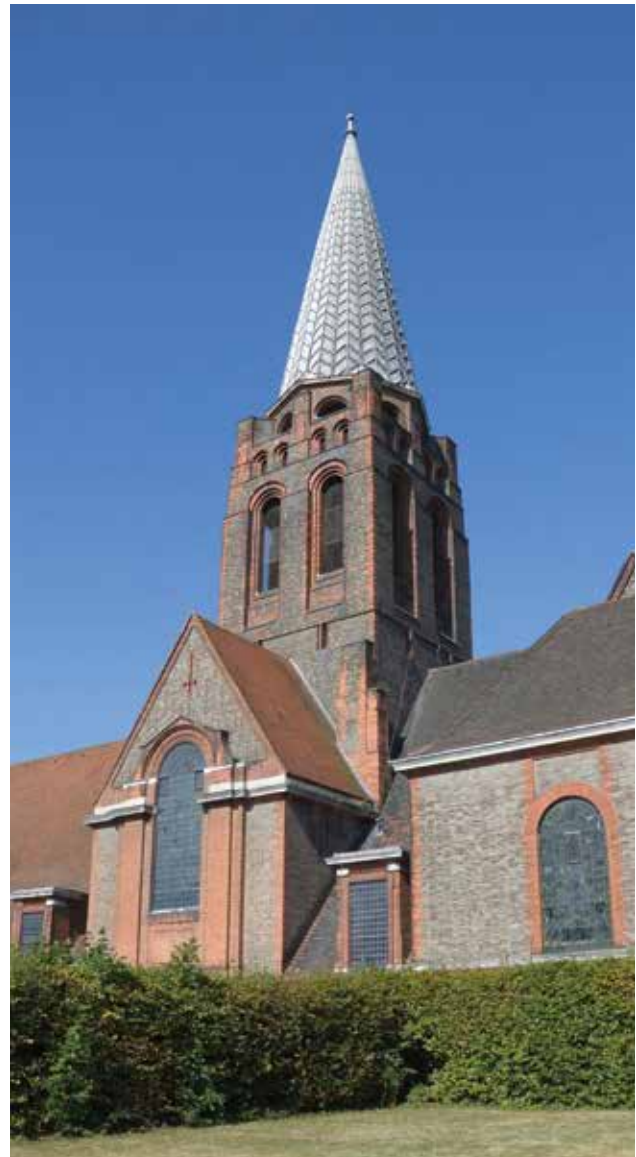
Fig 1 St Jude’s viewed from the south east

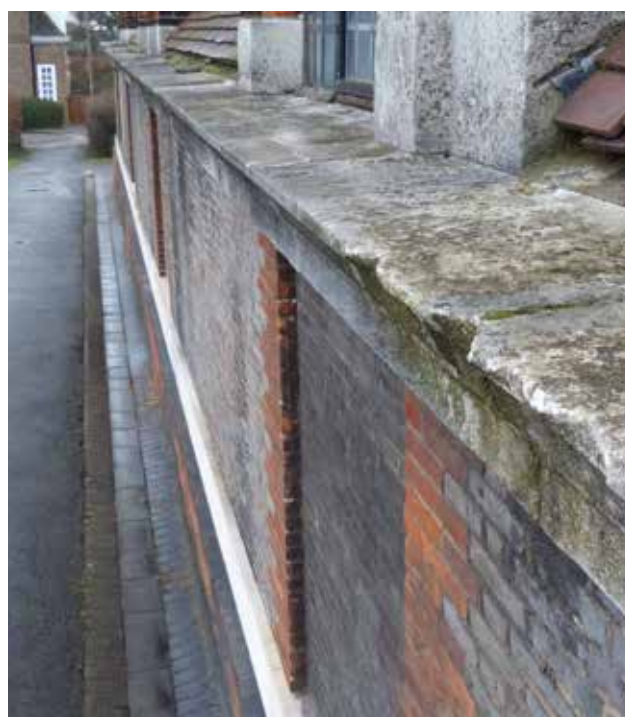
Fig 4 Detail of the cornice to the aisle walls with minimal fall to shed rainwater

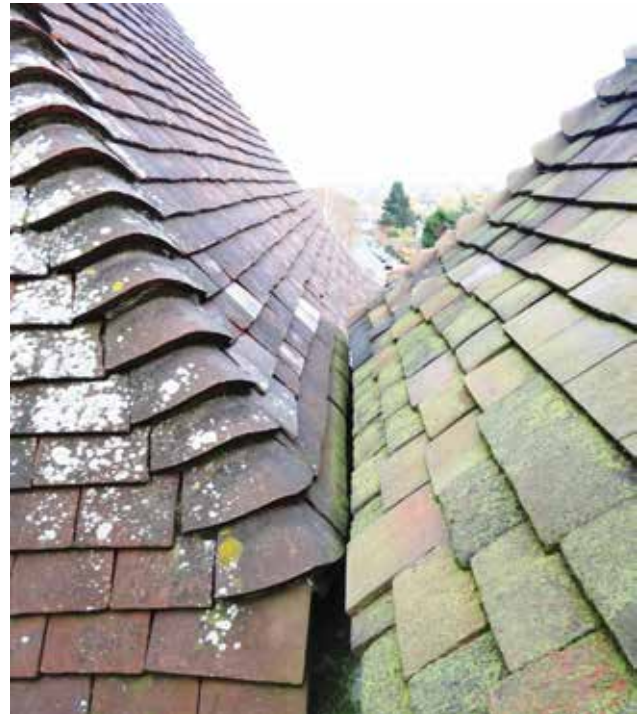
Fig 5 A difficult gutter to clean

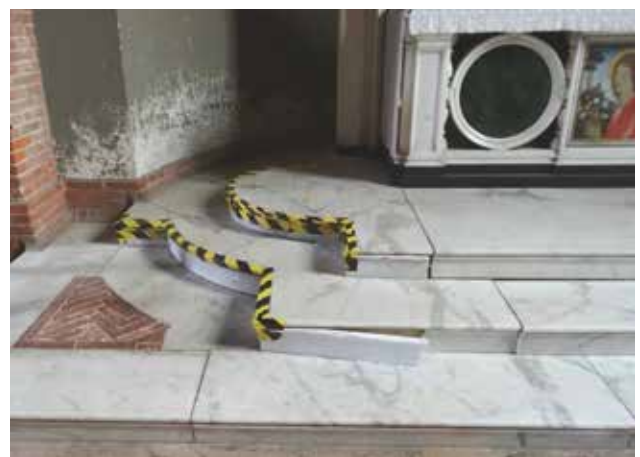
Fig 6 St John’s Chapel: water damage to wall and movement damage to paving

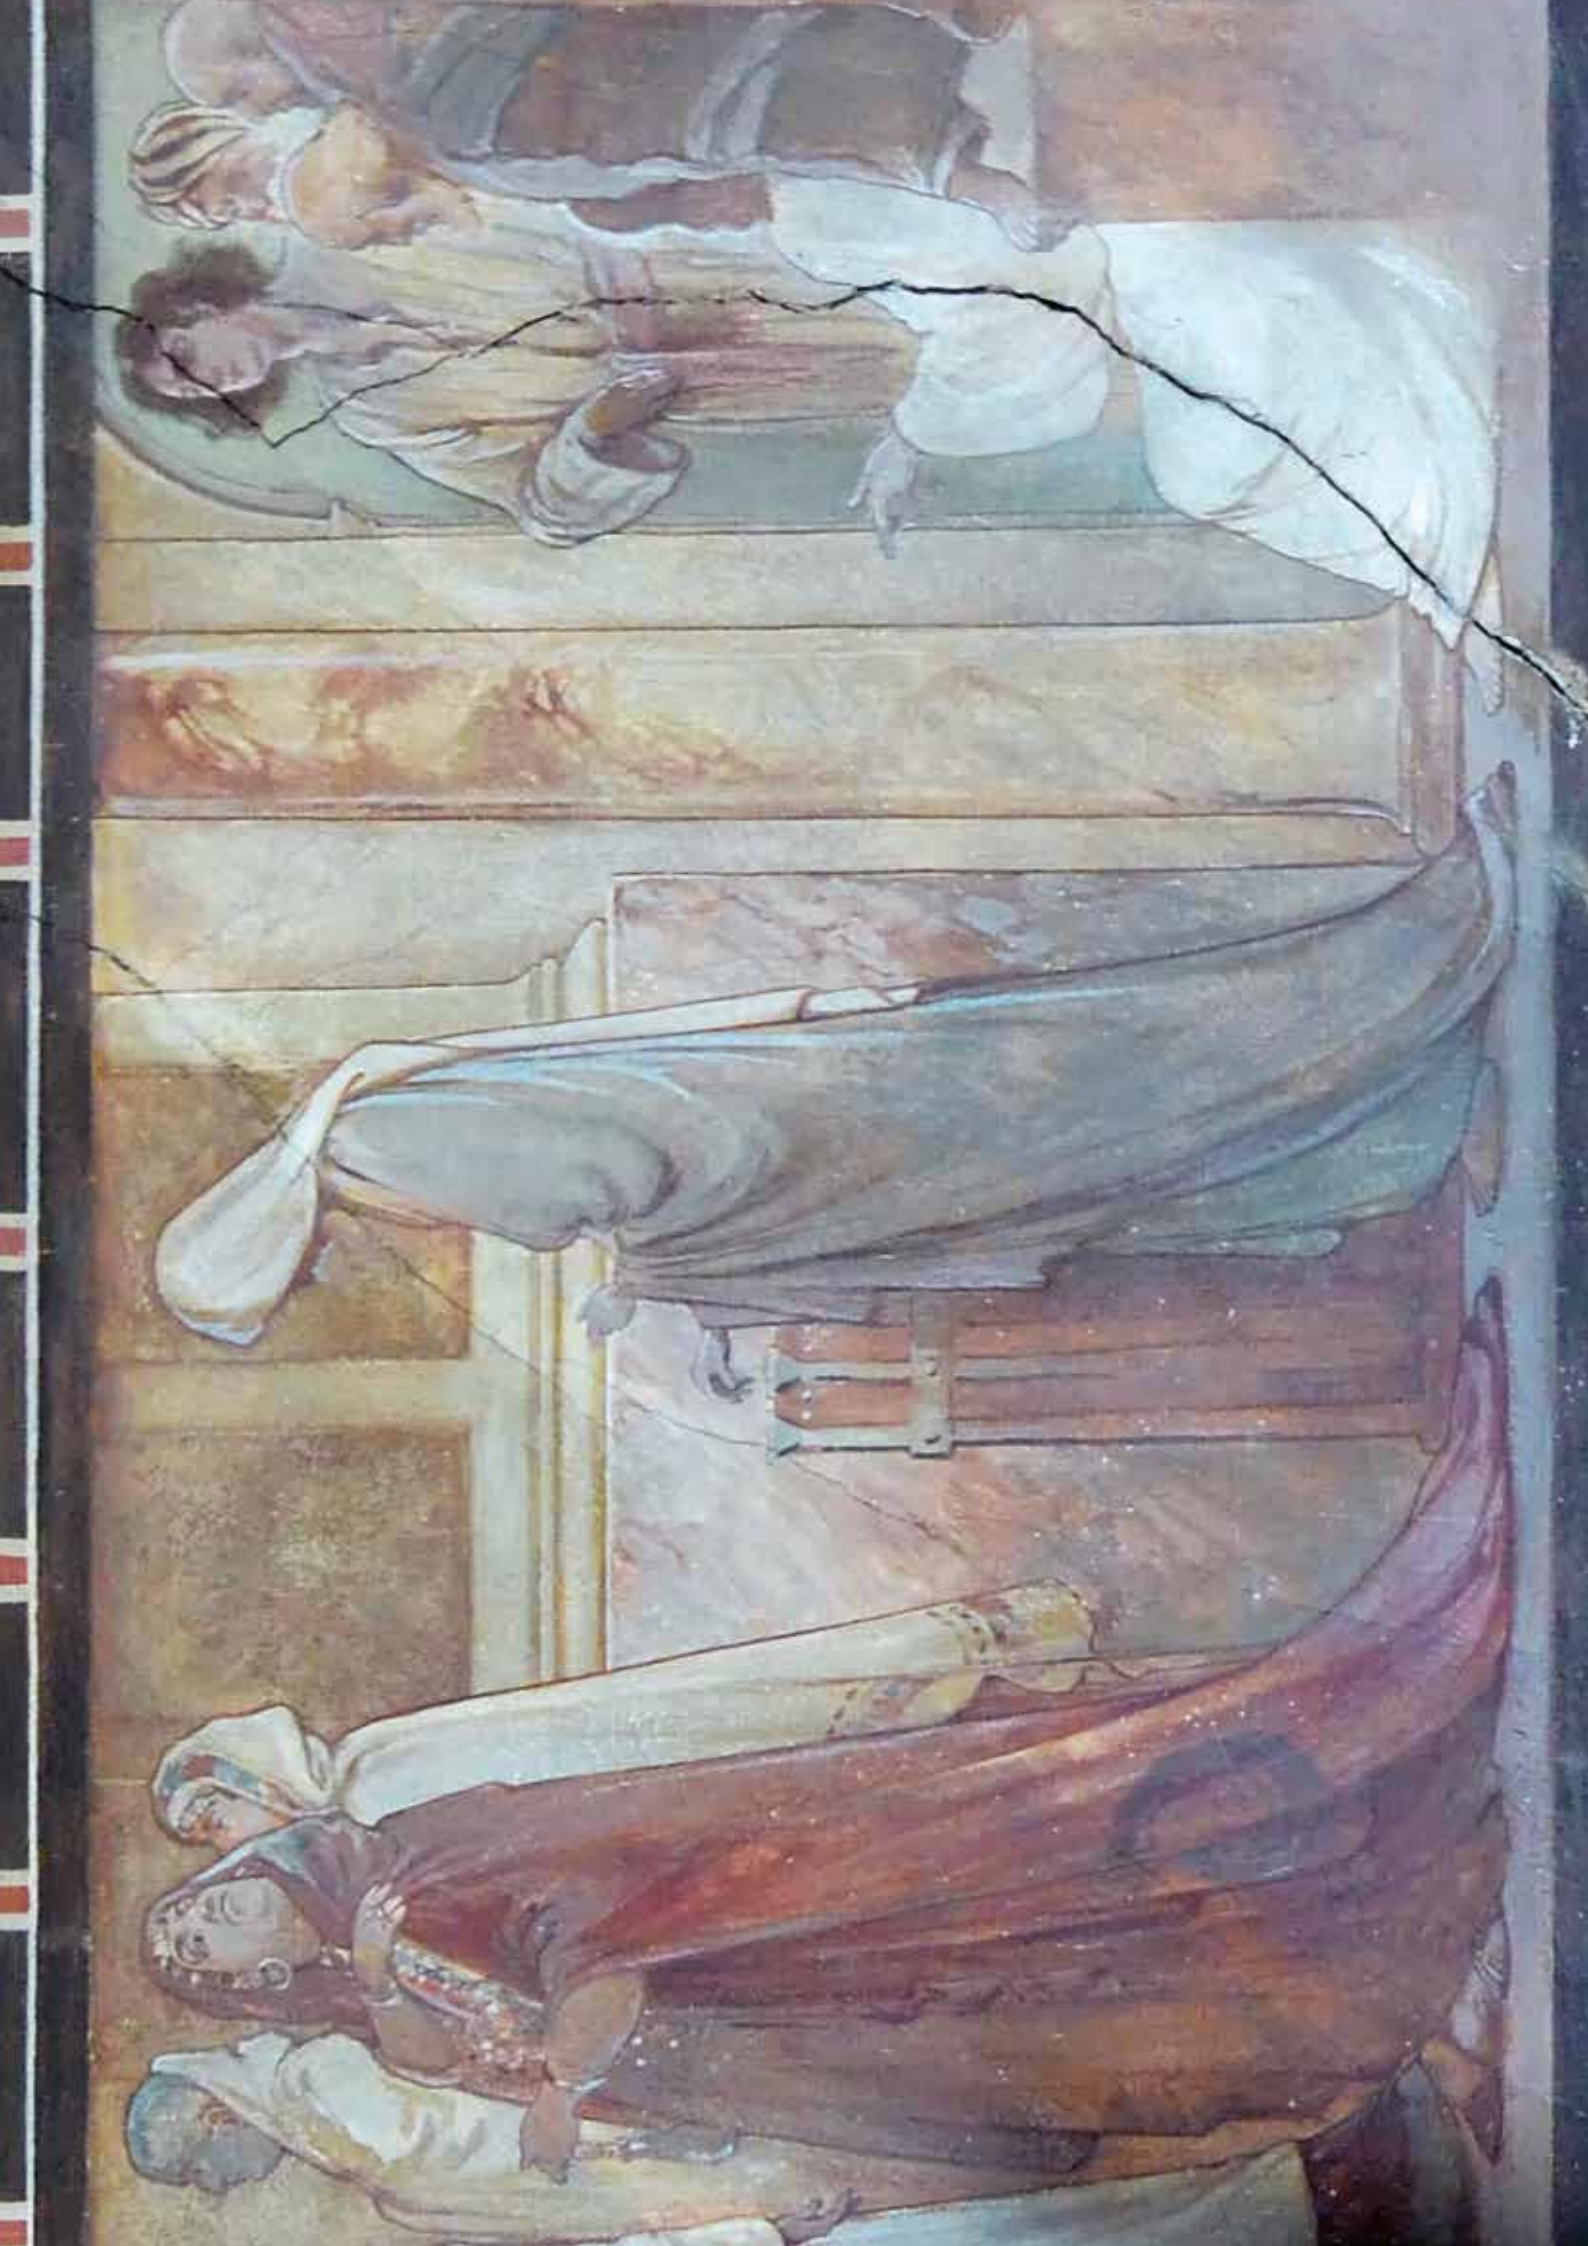
The heating installation also needs attention. The church is heated by low pressure hot water, currently supplied by an ancient gas-fired boiler located in the crypt, partly beneath the chancel. The boiler feeds imperial (4 inch) cast-iron pipework which is laid in a perimeter duct around the church and serves cast iron radiators set in bays in the external walls.

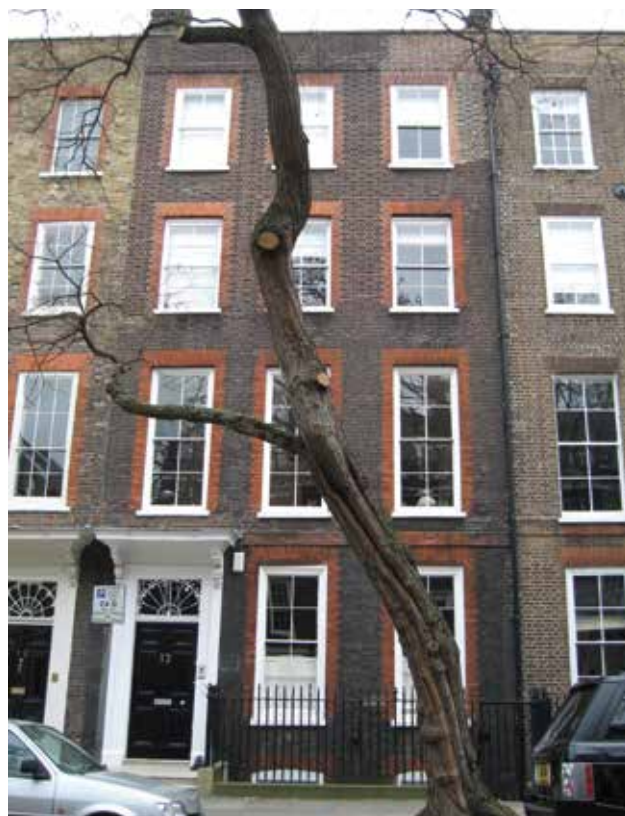
Fig 1 The front façade in 2008 before work began

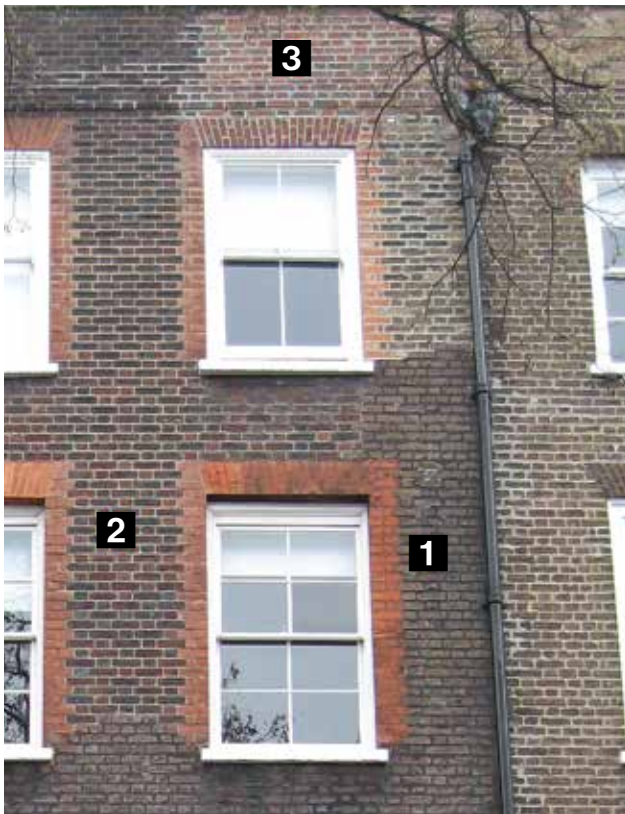
Fig 2 Detail of the unrestored front façade in 2008 showing original work (1), the 1900 resurfacing at second and third floor levels (2) and poor 2002 repair work which had used metric bricks and crude repointing in cementitious mortars (3)

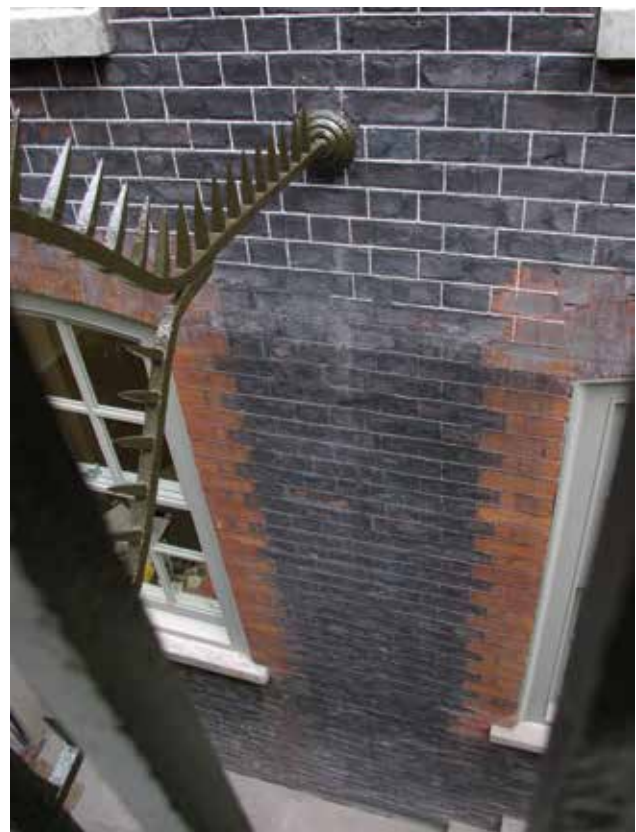
Fig 3 Detail of the restored front façade in 2008, showing original tuck pointing at lower ground floor level

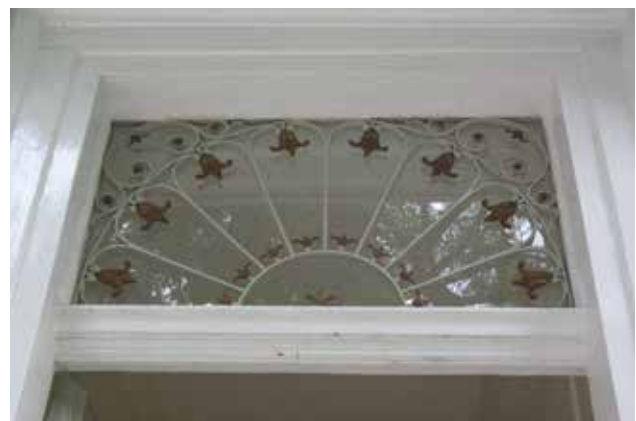
Fig 5 Restored fanlight over the front door, 2008

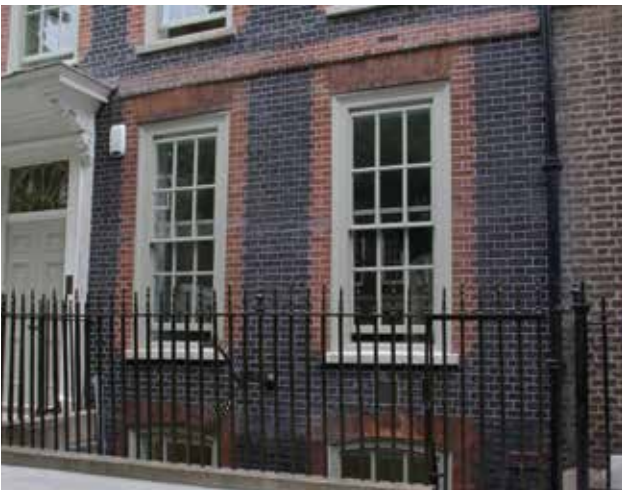
Fig 6 Detail of the restored front façade and railings, 2008

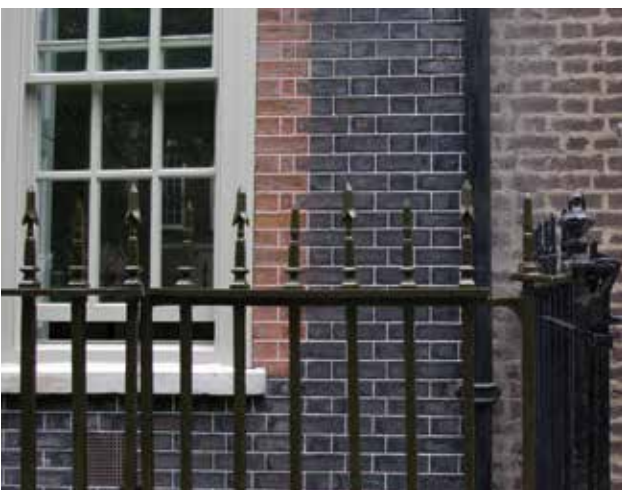
Fig 7 Detail of restored cast iron forecourt railings, tuck pointing, fenestration and window cill, 2008

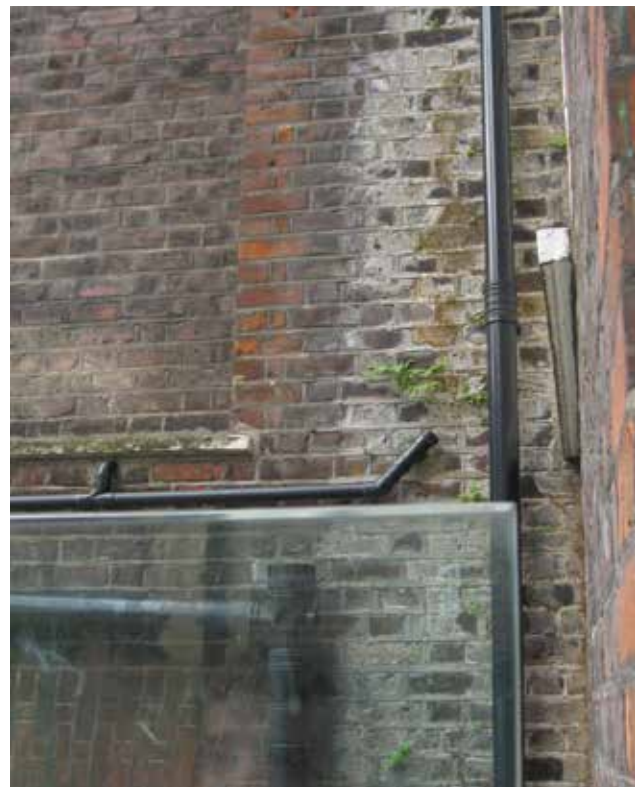
Fig 8 Existing salt contamination and plant growth on the rear façade brickwork, 2008

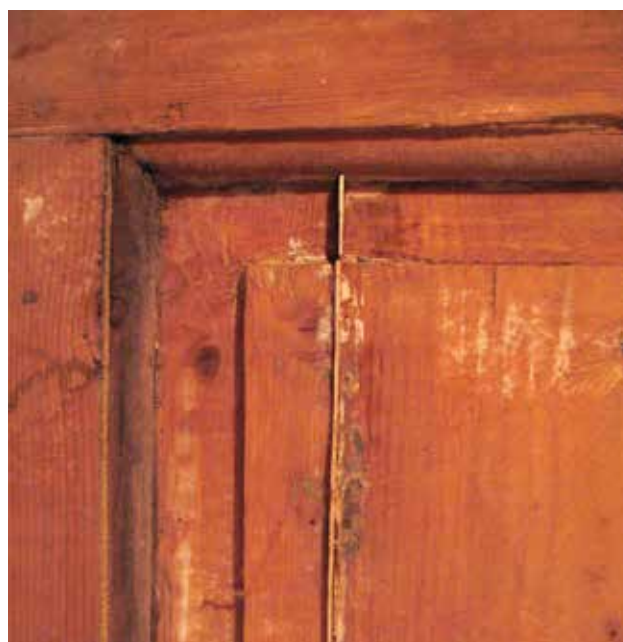
Fig 9 Detail of existing panelling under repair, 2008

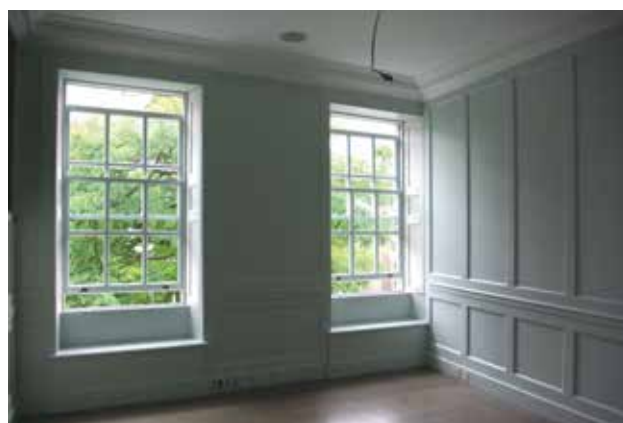
Fig 10 Repaired internal joinery, 2008

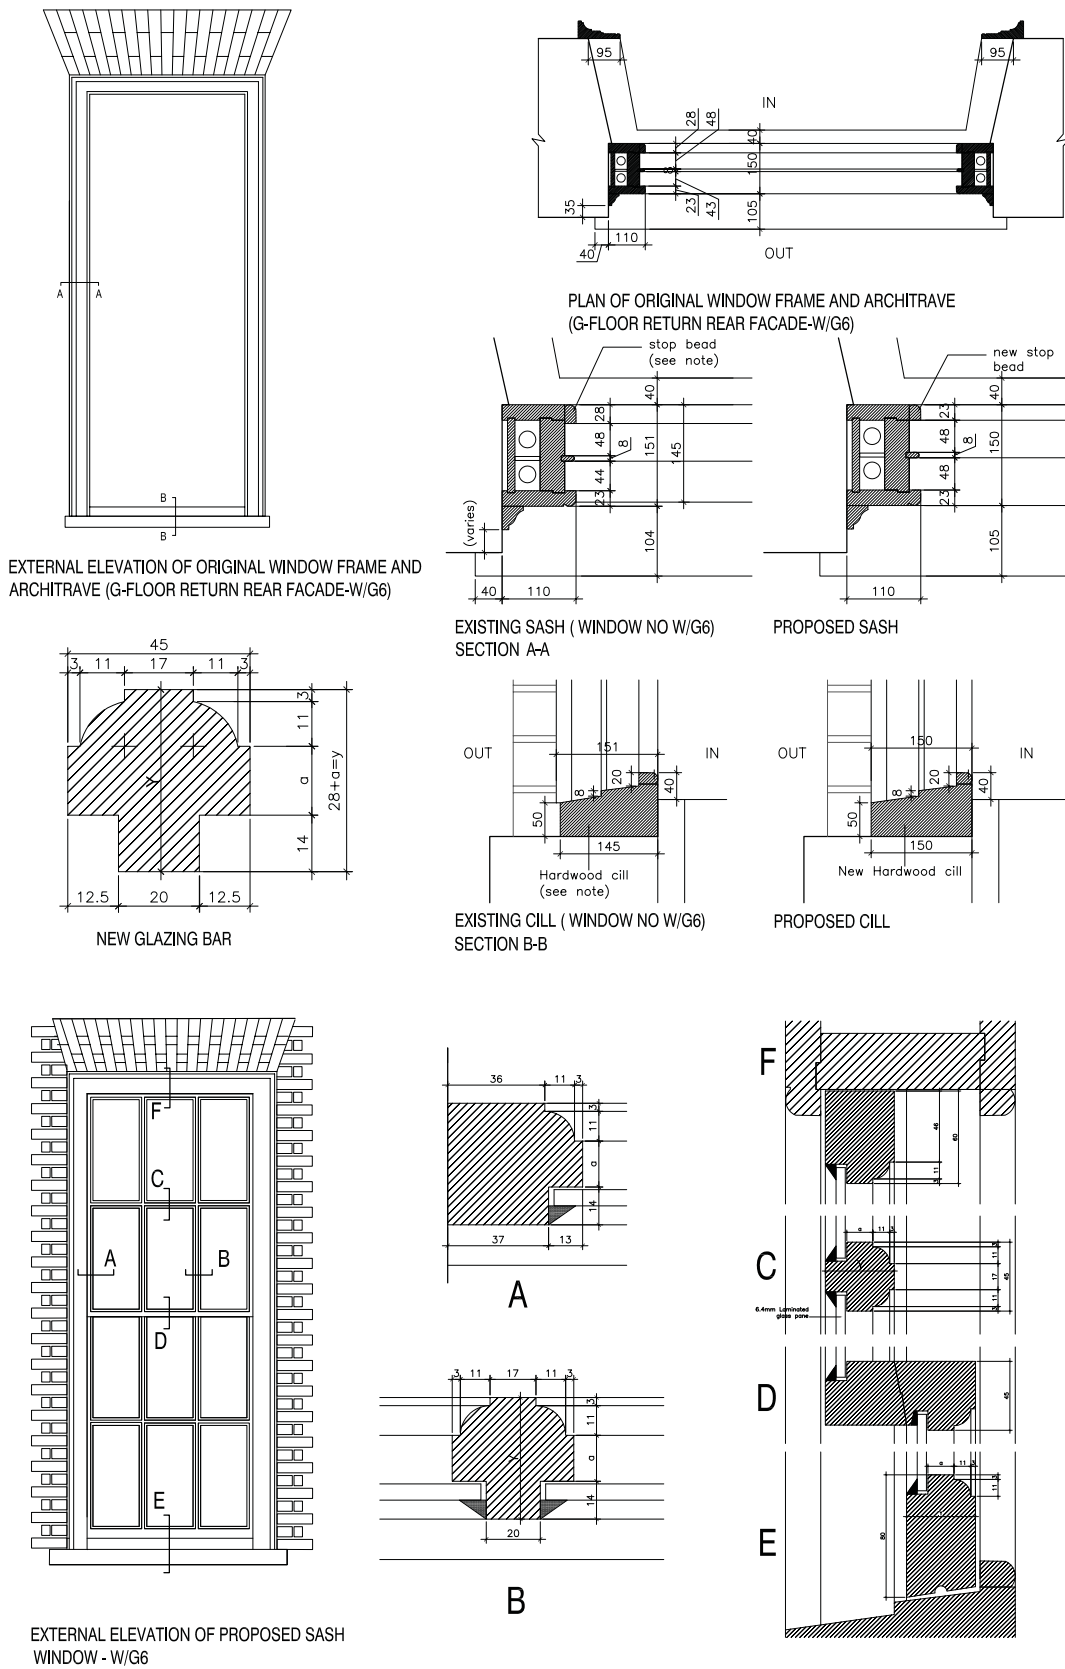
Fig 11 Drawings showing original box frame and architrave at ground floor level and proposed new sash window detailing throughout ('a' and 'Y' on the New Glazing Bar section refer to the diminishing thickness of the wall at higher levels which affected the depths of both glazing bars and box frames)

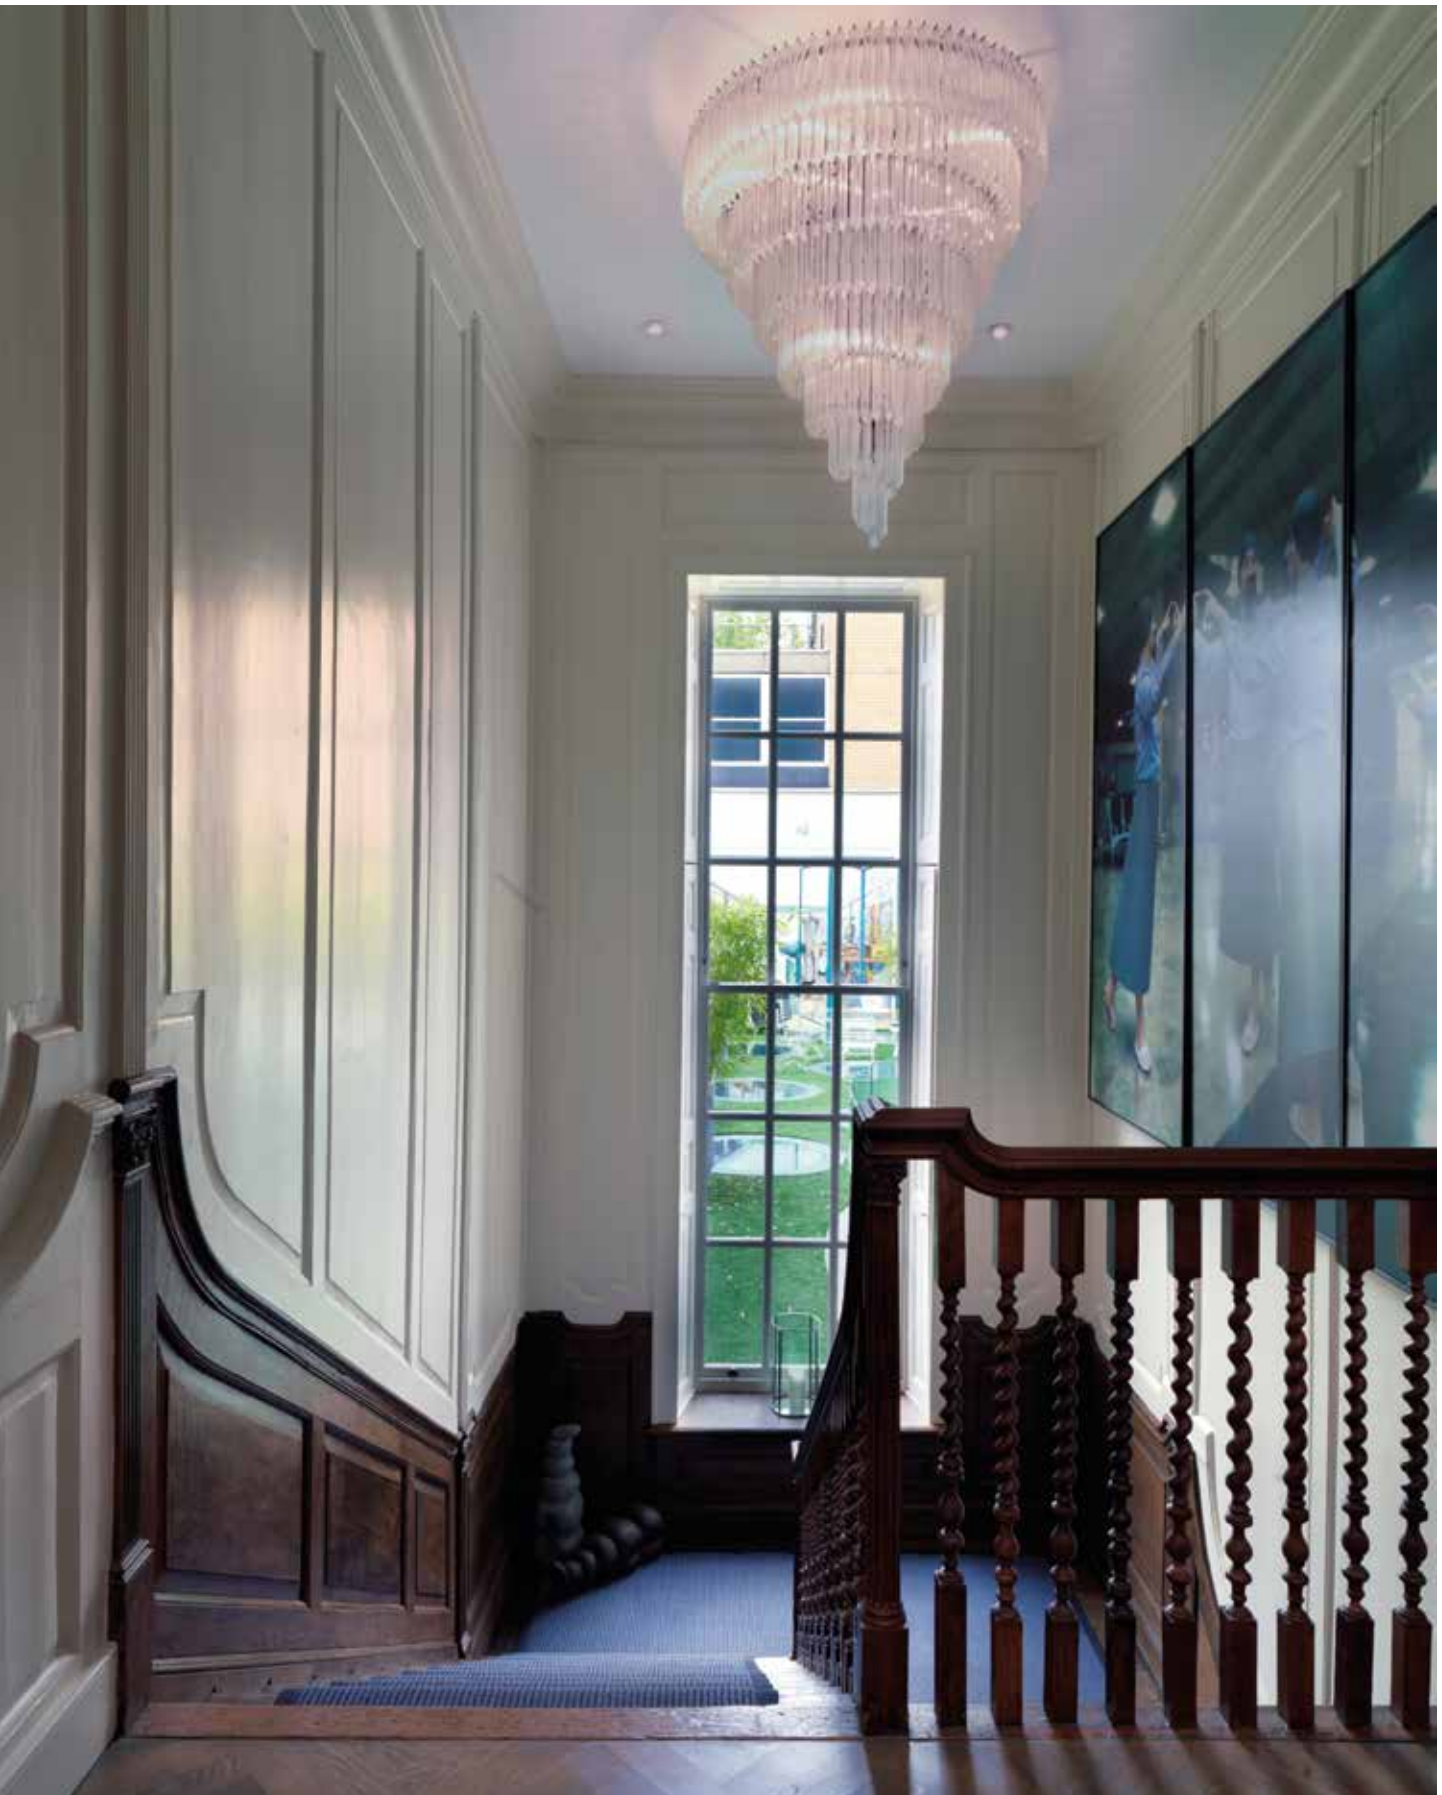
Fig 12 Oak staircase with dado height oak panelling exposed and restored, 2008

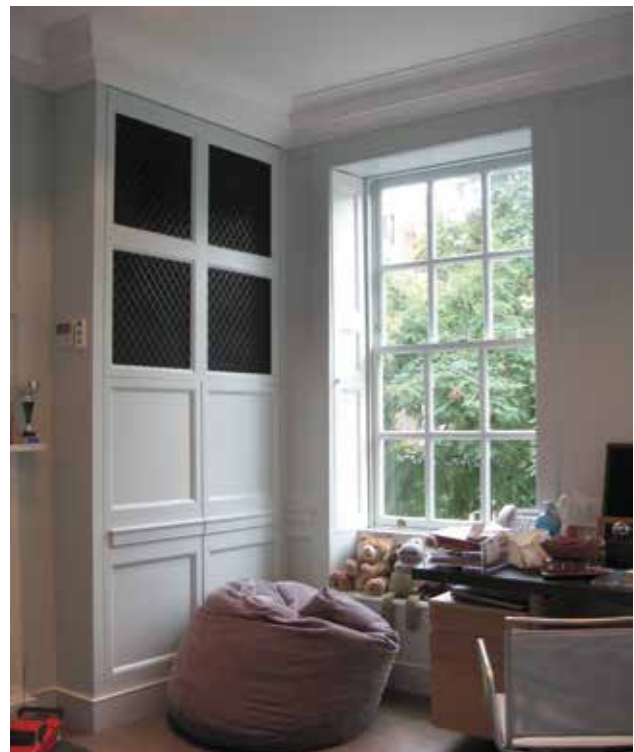
Fig 13 Refurbished front room at first floor level, with new cabinetry incorporating a new cooling system, and reinstated missing shutters, 2008
