ASSOCIATION FOR STUDIES IN THE CONSERVATION OF HISTORIC BUILDINGS

ASCHB TRANSACTIONS VOLUME 39: 2017

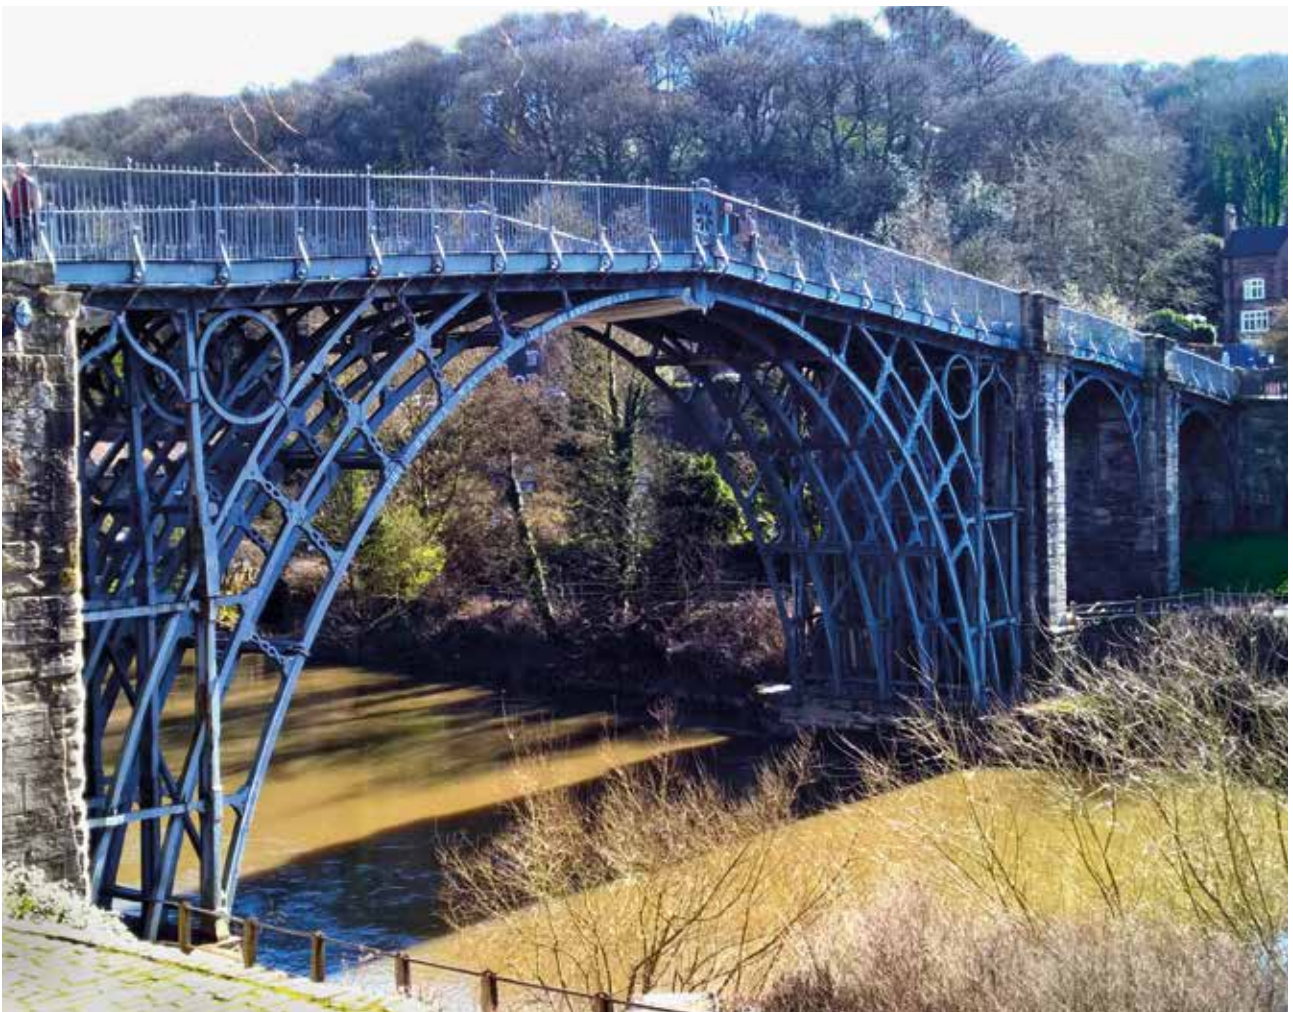
Fig 1 The Iron Bridge, Shropshire, upstream, west elevation

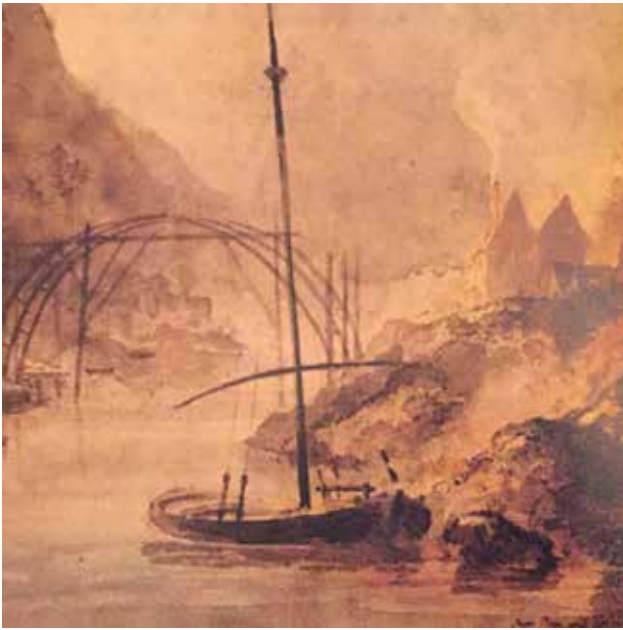
Fig 3 The Iron Bridge during construction (Elias Martin, 1779)

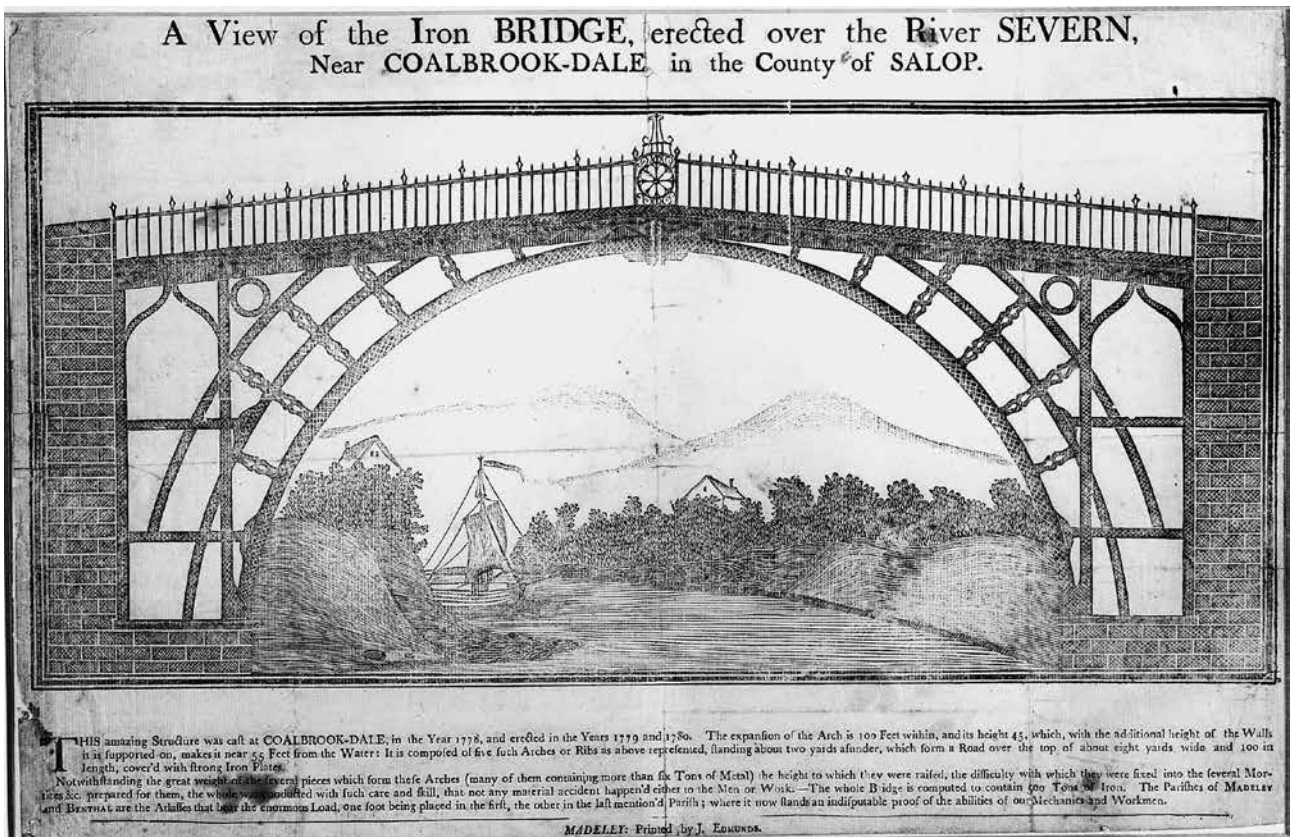
Fig 4 Woodcut by J Edmunds (1780): the missing bottom sections of the outer ribs were not added until 1791

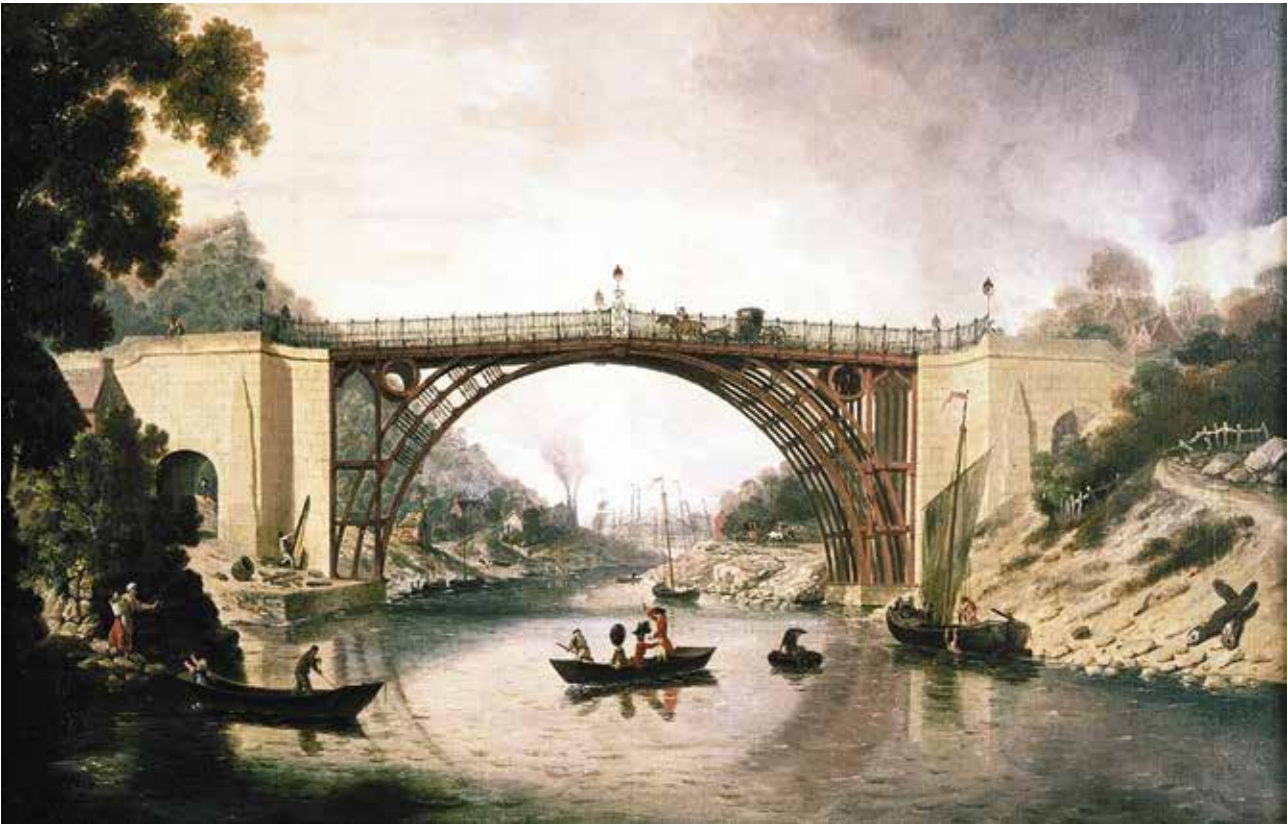
Fig 5 William Williams' 1780 depiction (detail) of the east elevation, showing the original bridge and south abutment, before the two south arches were built

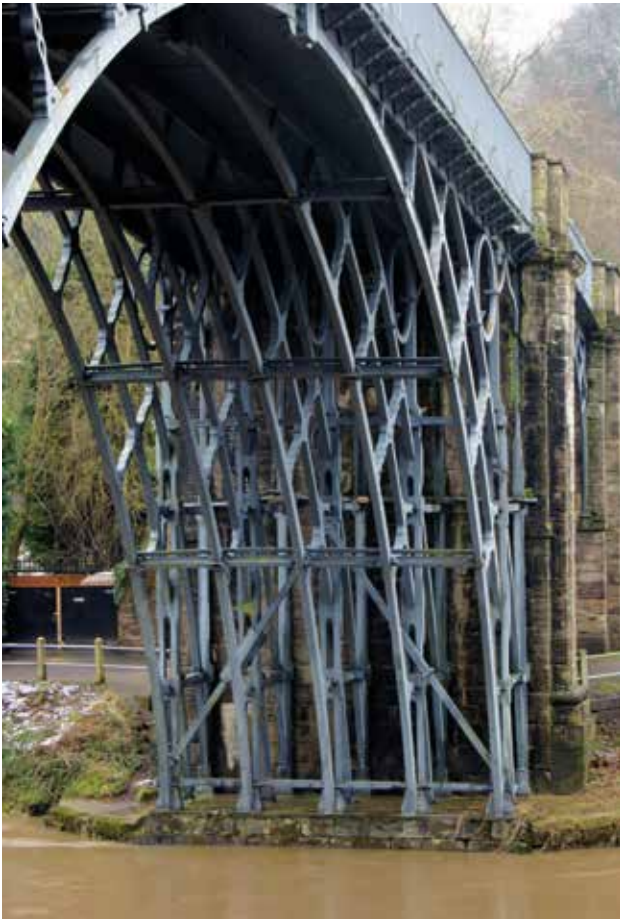
Fig 6 South bank showing horizontal strap just above the feet of the uprights and splint to diagonal bracing, both added following Sir Benjamin Baker's inspection in 1902

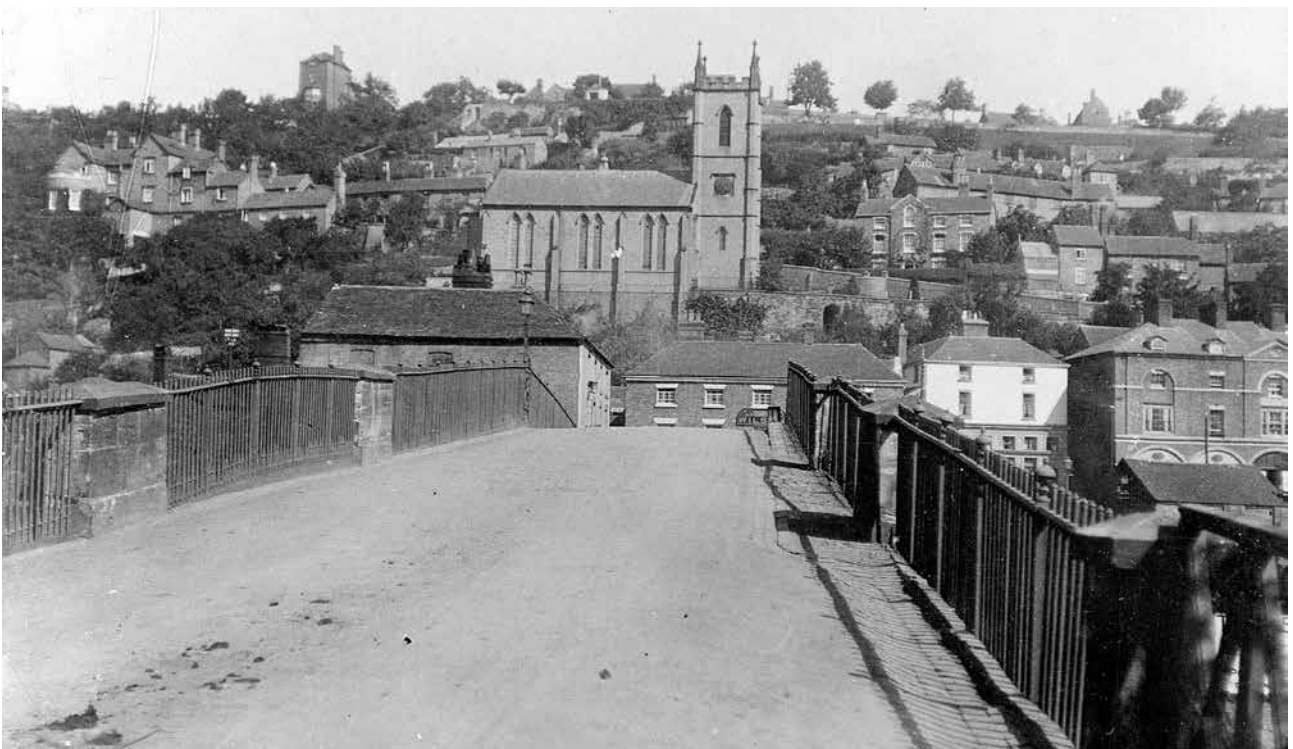
Fig 7 The roadway c1920 without footpath

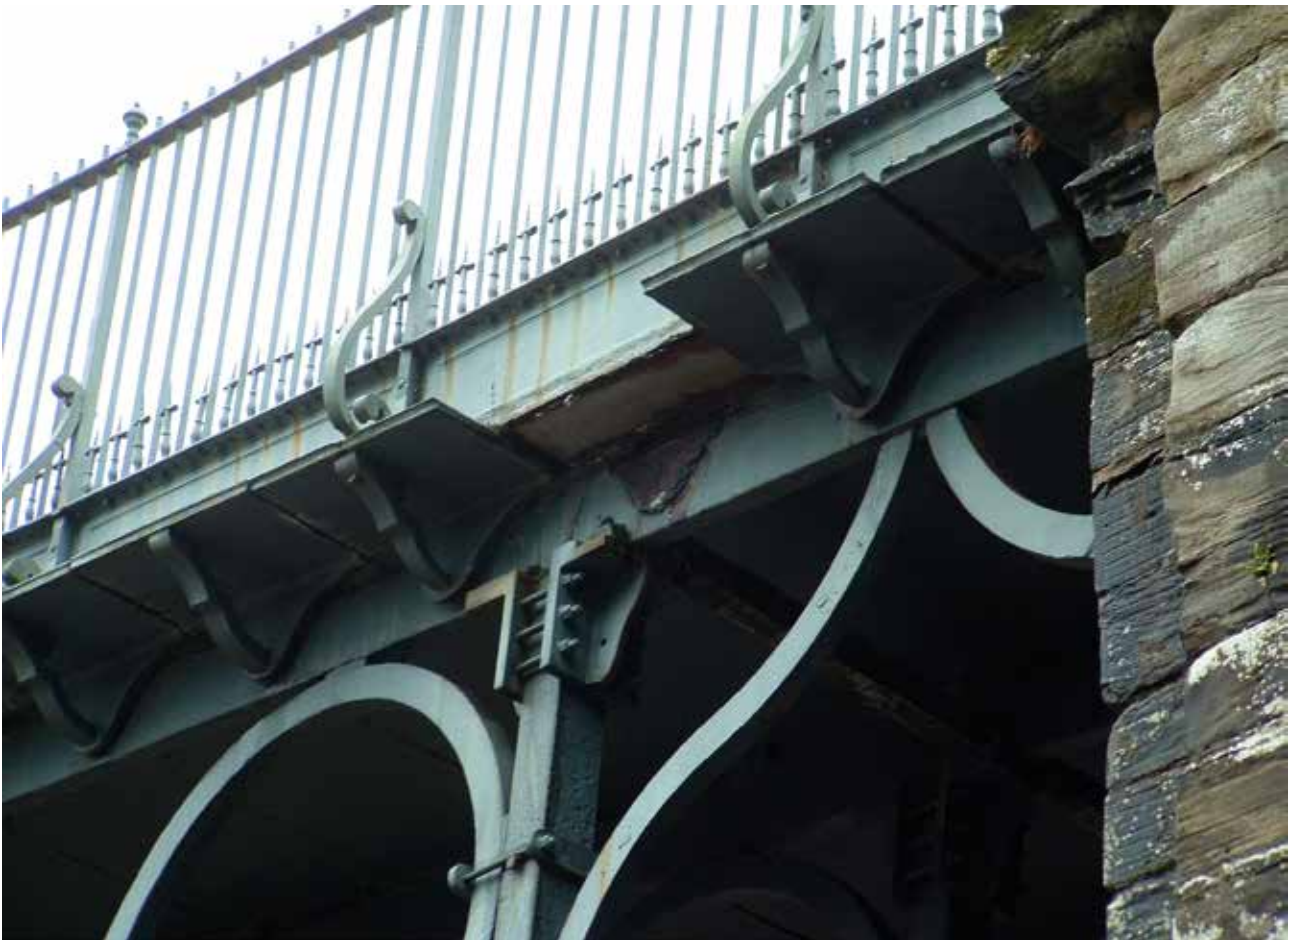
Fig 8 Saddles added at the top of the uprights to support the cracked bearers in 1927, following recommendations by the bridge trustees' surveyor Luther Griffiths, and missing deck plate end

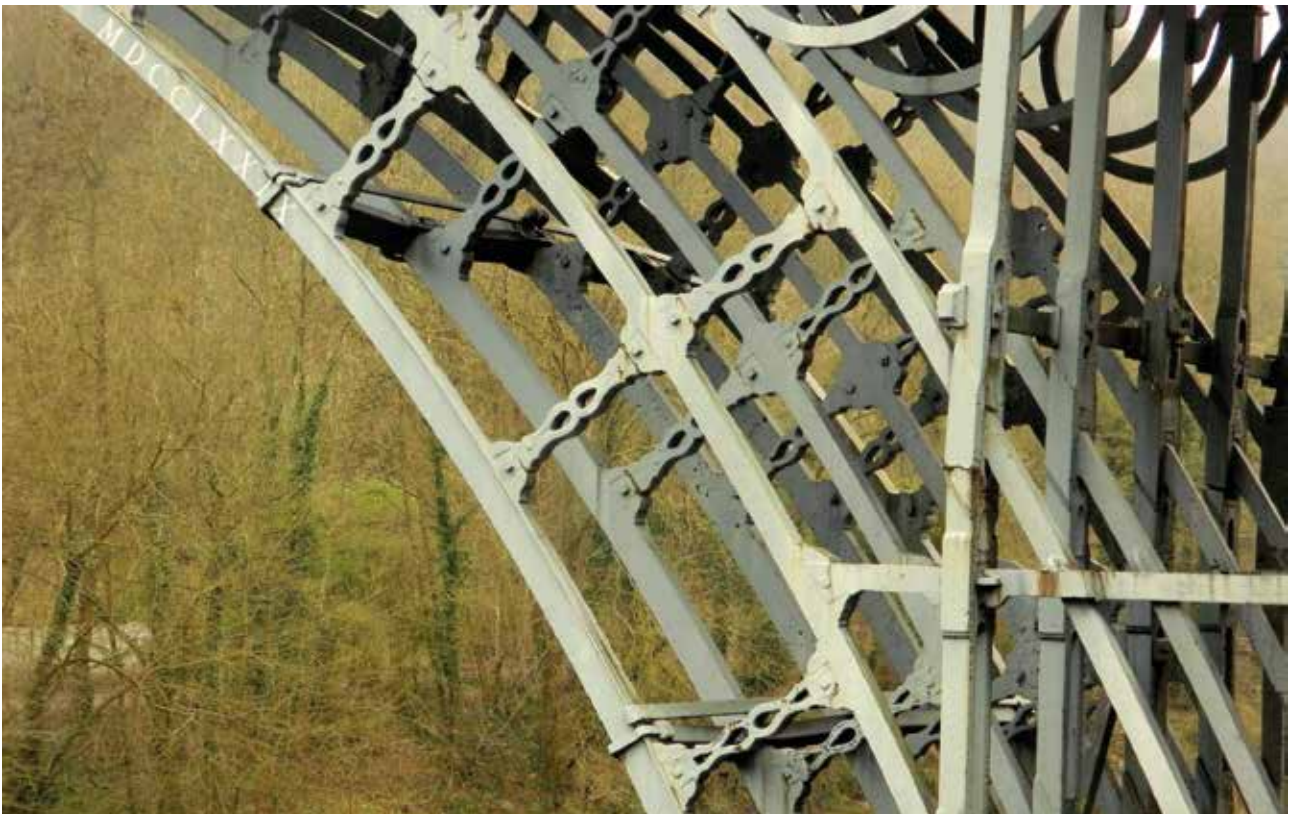
Fig 9 Radials of varying shapes and sizes

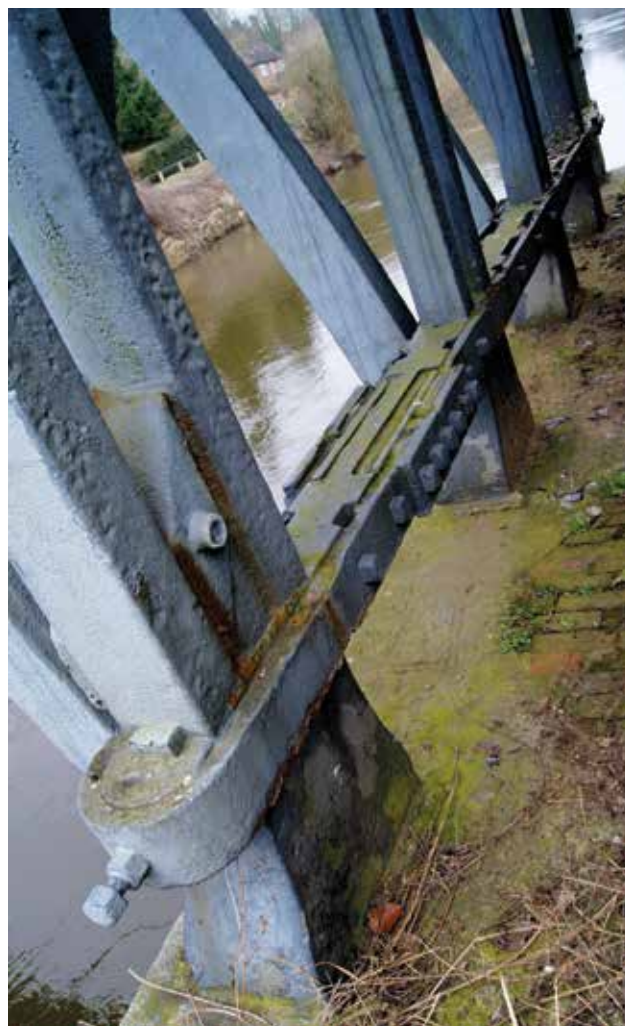
Fig 10 Photo of south bank steel straps and cast iron blocks installed after inspection by Sir Benjamin Baker in 1902 to restrain the feet of the uprights

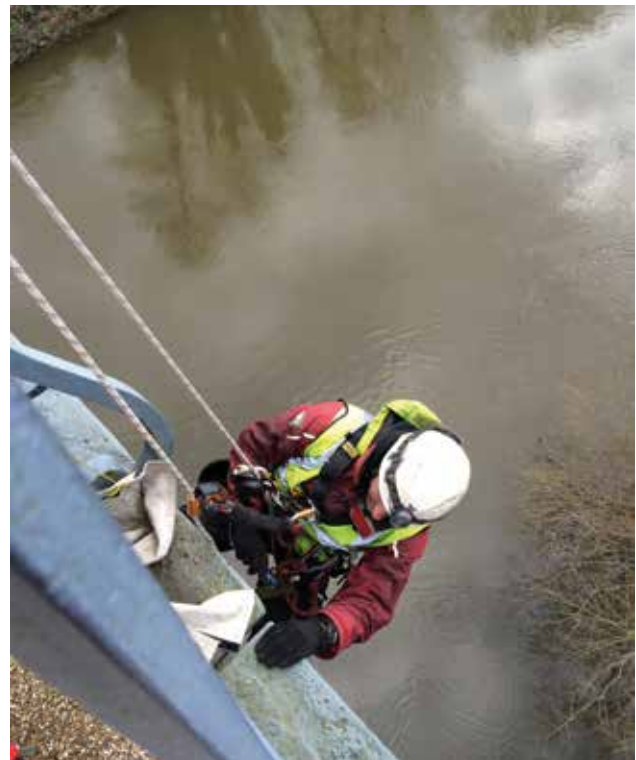
Fig 11 Roped access inspection being undertaken by Vertical Technology Ltd

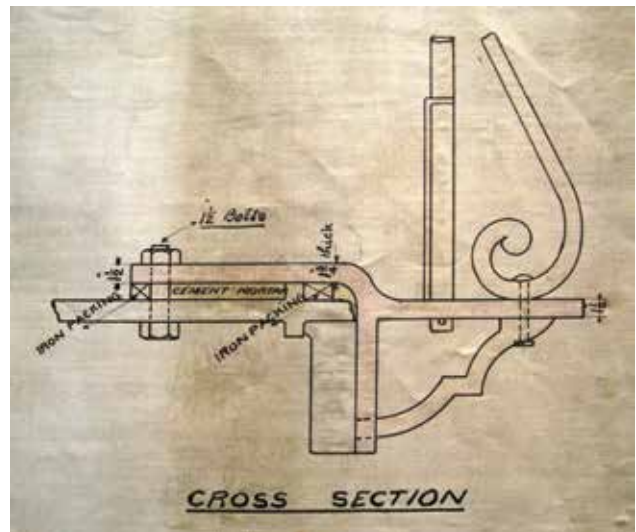
Fig 12 1902 deck plate end repair

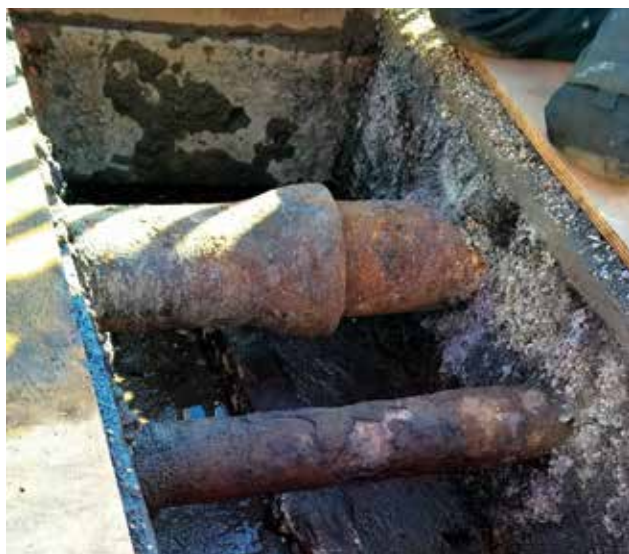
Fig 13 Trial hole investigations showing upstand to deck plates at right angles below the service pipes

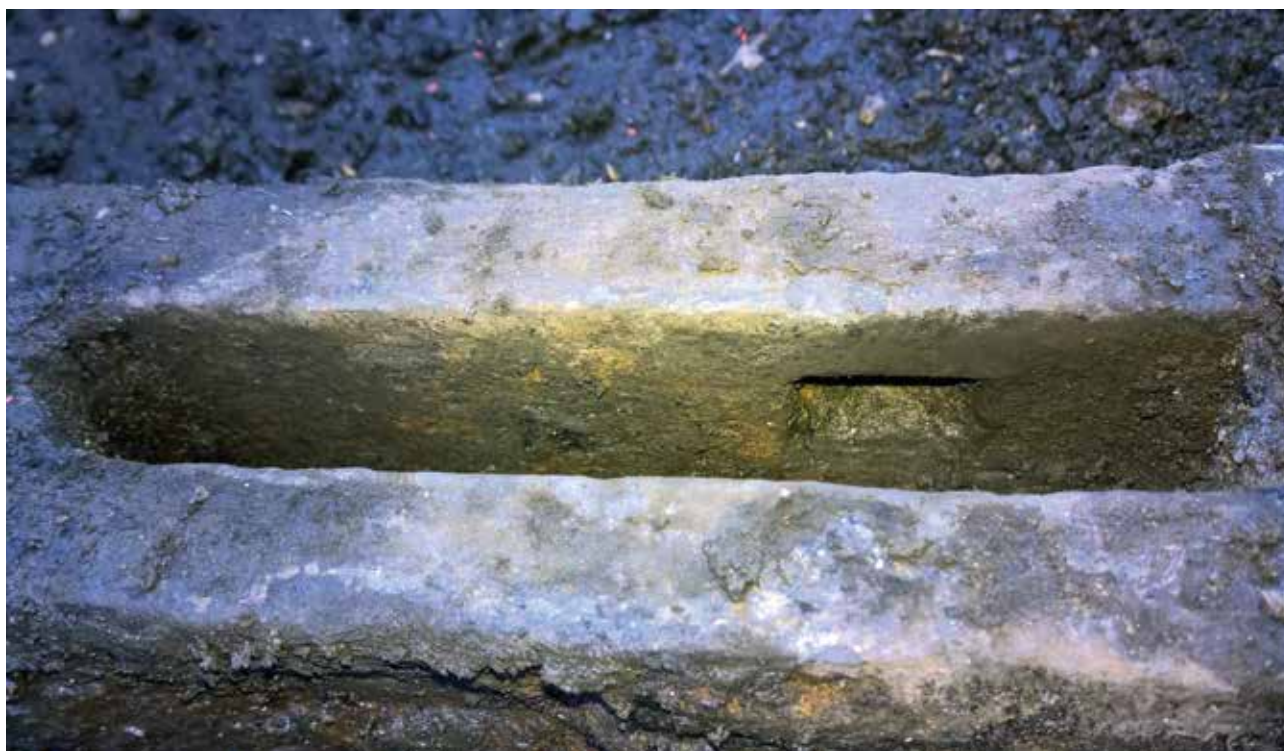
Fig 14 South span deck plate upstands with small notch, possibly for lifting plates into place

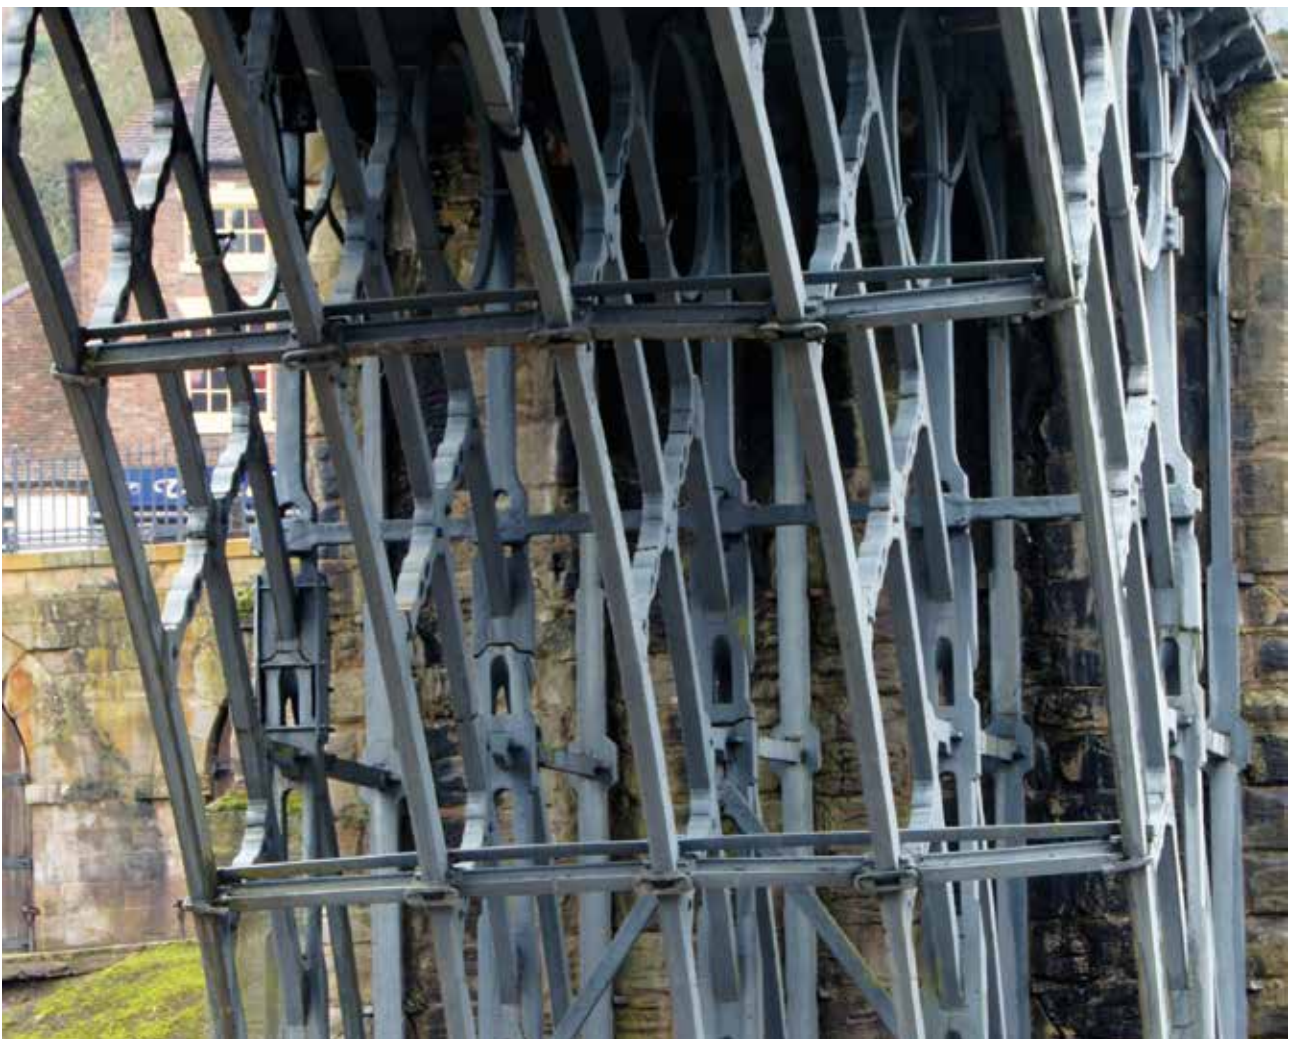
Fig 15 North bank rib bracing showing original cast iron spacers and 1926 steel straps

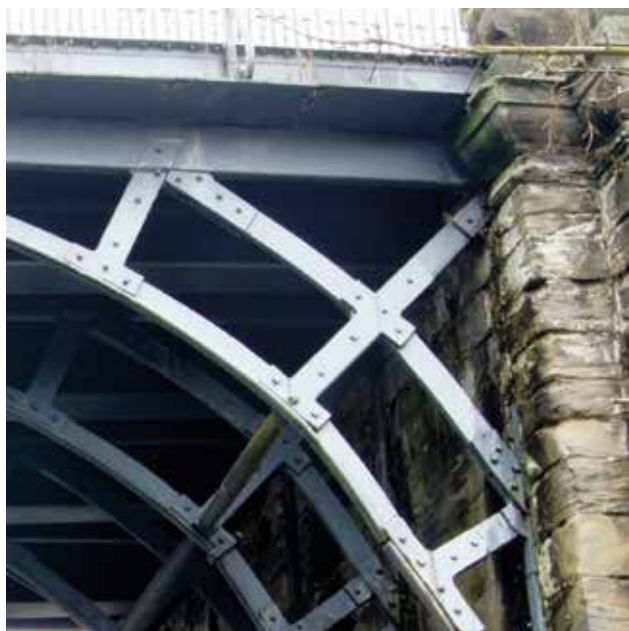
Fig 16 South span showing cracked ribs, gusset plates and inserted beams
