TRANSACTIONS VOLUME 23 1998

Association for Studies in the Conservation of Historic Buildings

Conservation in Northern Ireland since 1969 by Marcus Patton OBE BSC DipArch RIBA	3
The Grandstand at Stamford: Its History, Repair and Re-use by Dr Jennifer Freeman BA(HONS) GradDiplCons(AA) IHBC	15
How we Select what to Conserve: Unlisted Buildings within Conservation Areas by Deborah Pope BA DipArch with Landscape Des pgDipArchCon & Linda Watson BSC BArch DipArchCons	25
Hill Hall, Essex: The Post-fire Restoration by Nick Hill MA BSC ARICS GradDiplCons(AA)	29
The Parthenon: A Visit by Cathy Fisher BAS BArch GradDiplCons(AA) RIBA IHBS AABC	50
Gauged Brickwork: Tracing the Netherlandish Influence by Gerard Lynch LCG CertED MA(Dist) & David Watt BSC(HONS) DipArchCons(Leic) PhD MSc FRICS IHBC	52
A Celebration of Earth Buildings of Great Britain and Ireland by Linda Watson BSC BArch DipArchCons	67

THE GRANDSTAND AT STAMFORD: ITS HISTORY, REPAIR AND RE-USE

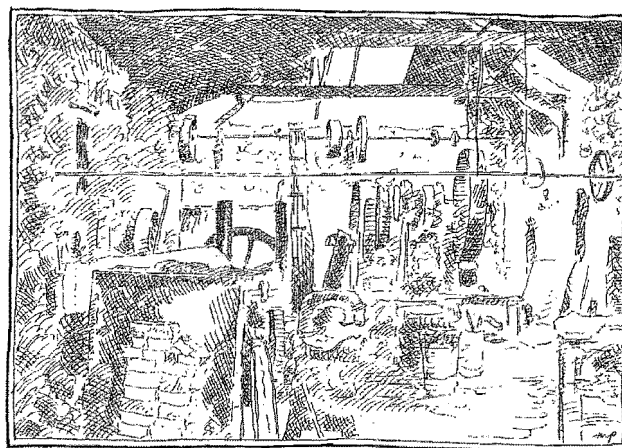
Figure 5 Patterson's Spade Mill, Templepatrick, Co Antrim (1992). Spades were an essential part of the rural economy of Ireland, and spade mills once a commonplace throughout the island. However when the Patterson family decided to give it up the National Trust took on the last working spade mill in its original location, and restored it to full working order in 1994 without altogether losing the ramshackle chaos of belts and pulleys it displayed when they took it over.

Perhaps the only body carrying out consistently fine restoration in Northern Ireland throughout the last thirty years has been the National Trust – founded in the province in 1937 with generous backing of the Stormont government via the Ulster Land Fund – which incidentally held its national AGM in Northern Ireland for the first time in 1999. As part of a national body it has applied the same standards to its work at Castle Ward or Castle Coole as to any English or Welsh properties. The refacing of stonework at Castle Coole was a particularly monumental task, but they have also carried out extensive work to the Temple of the Winds at Mount Stewart, the Mussenden Temple on the cliffs at Downhill, and to many smaller properties they own, like the Clough Williams-Ellis houses at Cushendun, and the tiny ice house on the recently acquired slopes of Slieve Donard in the Mourne Mountains. One of their more recent projects was the restoration of the last working spade mill in Ireland at Templepatrick, where a tiny water turbine drives an extraordinary array of hammers, drills and cutters by a series of belt drives (figure 5).

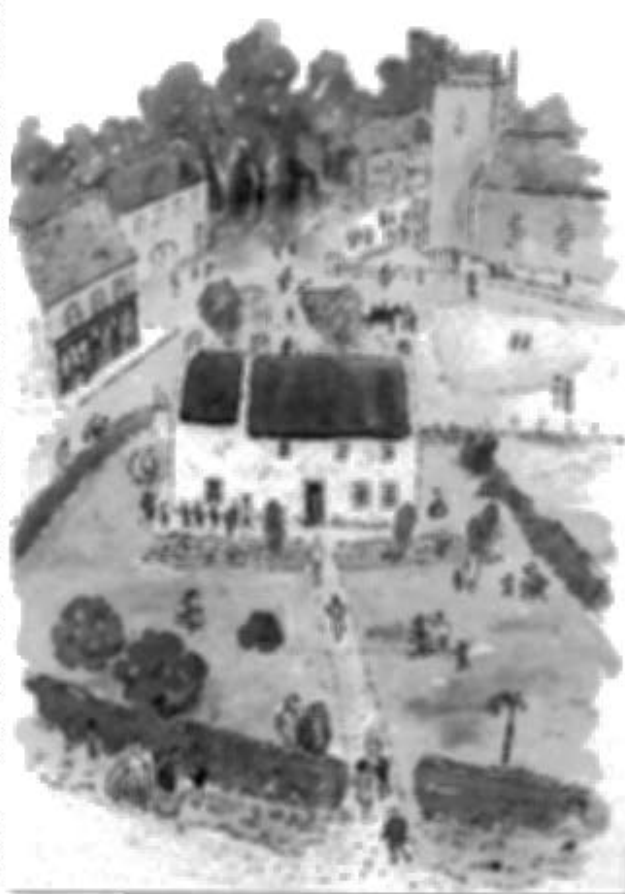
Figure 6 Lismaecoskey Rectory, Ulster Folk and Transport Museum, Co Down (1989). This substantial thatched building is a focal point in the buildings collection at the Folk Museum.

Perhaps the best collection of vernacular buildings is at the Ulster Folk Museum at Cultra just outside Belfast, where many buildings threatened with demolition have ended up (figure 6). It is an excellent and very popular educational establishment, but inevitably it does take buildings out of the real countryside and plant them in a sort of zoo.

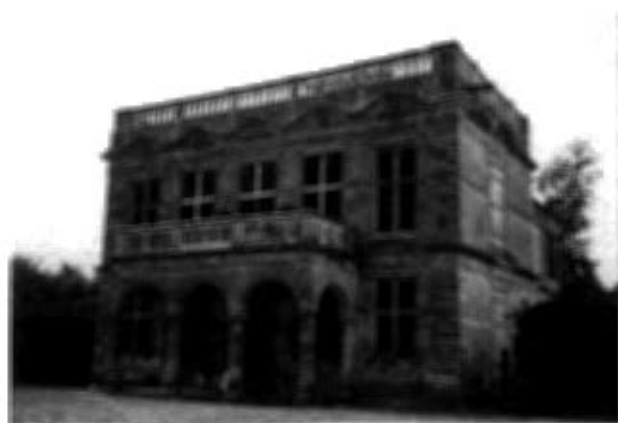
Figure 1 Lodge Park, Sherborne, Gloucestershire (c.1634), stand for viewing deer coursing. (Author)

The earliest viewing stand known to the author is at Lodge Park, Sherborne, Gloucestershire, currently being repaired by the National Trust under architect Jeffrey Howarth (*figure 1*). The stand has been dated to about 1634 and may be the work of Nicholas Stone, John Webb or another contemporary of Inigo Jones.⁴ All the elements of later grandstands are present in the design and layout of the building, which is arranged on three floors with a viewing platform on the roof. It is five bays wide. A hall or reception area is formed at ground floor level with the first floor occupied by a near double cube banqueting room 40 ft long. There was a stone-flagged kitchen with a fireplace in the basement. The banqueting hall also had a fireplace. A grand staircase led to it and a second gave access to the roof. Large windows opened on to the course at all levels. A distinctive and prestigious building type had emerged.

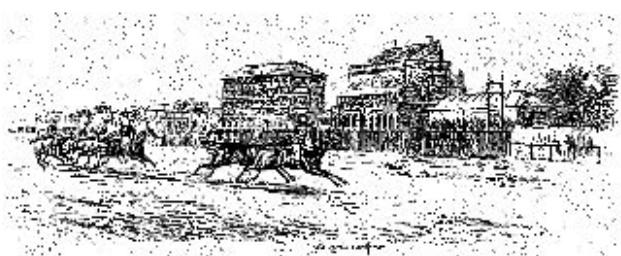
Figure 3 1890 view of Carr's grandstand at York. Note the rear wing and chimney; the tiered seating was added in the 19th century. (Tyrrel, 85)

John Carr of York (1723–1807) was the designer of the first and most famous of these eighteenth-century grandstands. It dated from 1751–5, and stood on the course at Knavesmire at York (figure 3).⁸ The remaining vestiges now function as a champagne bar. An early important commission for Carr, clearly he had in mind the prototype stand at Lodge Park when he designed this and later grandstands. These included one at Nottingham of 1777 and, largest and most elegant of all, the stand at Doncaster of 1777–81. There was a stand by Carr at Kelso in Scotland of 1778. The grandstand at Beverley,⁹ dating from 1767, was demolished in the 1920s; that at Richmond, probably designed by John Foss, a pupil of Carr, of 1775, is in a ruinous though

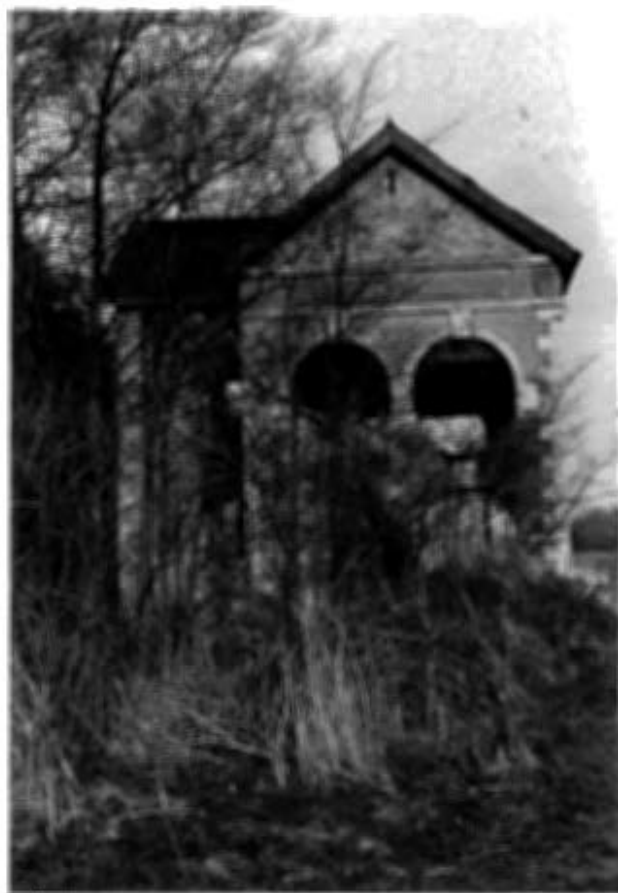
Figure 4 Stamford Grandstand from the west, March 1966. (RCHME)

reusable state. The subject of this article, the grandstand on the Burghley estate near Stamford, which dates from 1766, is arguably the second oldest (figures 4, 5, 6).

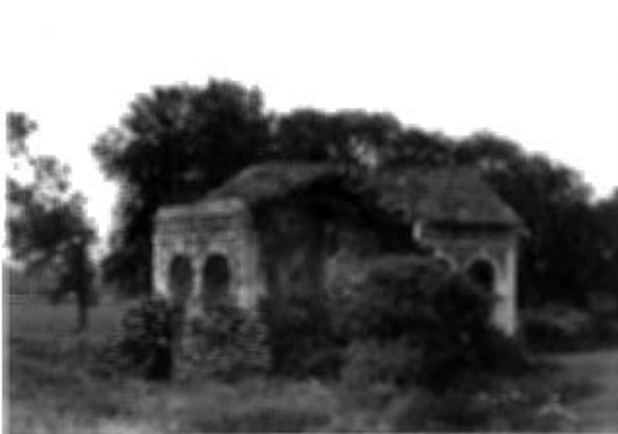
Figure 5 Stamford Grandstand from the south-west, June 1981. (RCHME)

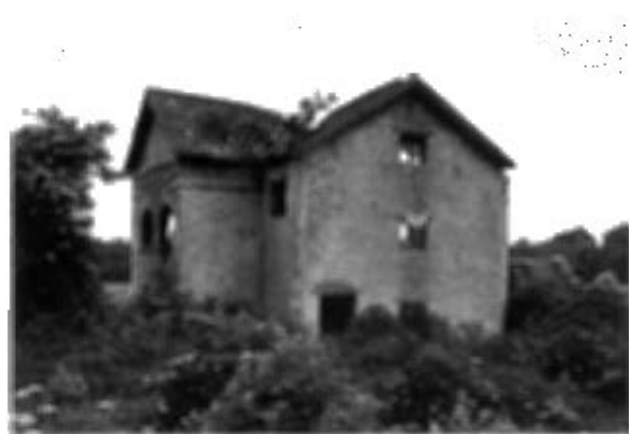
Figure 6 Stamford Grandstand from the north-east, June 1981. (RCHME)

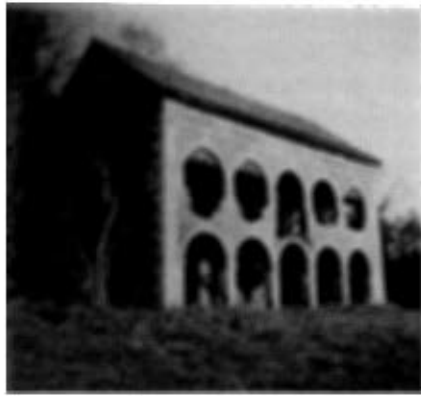
Figure 9 Stamford Grandstand, 1953, showing central arcade of upper storey lowered to form access to balcony of 1818–20. (Stewart Rodgers)

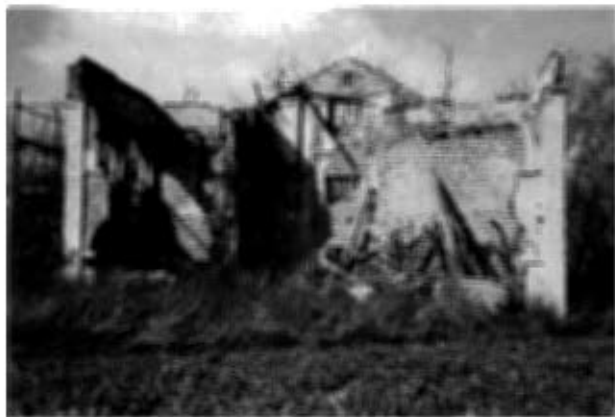
Figure 10 Stamford Grandstand, April 1995. Note patches of historic plaster; casement windows of 1766 and fallen remains of 1820 rendered parapet. (Author)

The site was first cleared of debris, all timber being first examined by the archaeologist and fallen stone and brick being set aside for reinstatement and re-use (*figure 10*). Patches of eighteenth-century plaster with at-

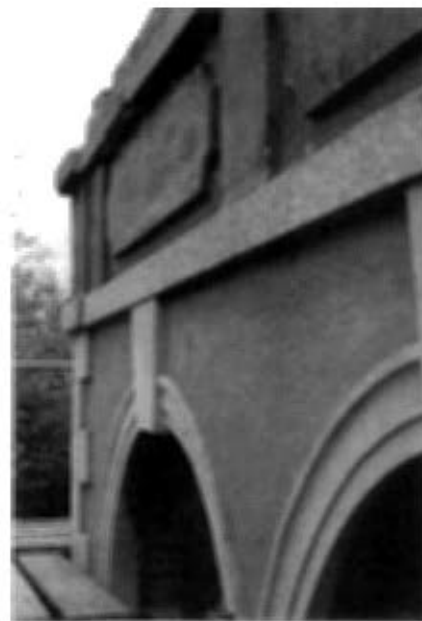
Figure 11 Close-up of ashlar dressings in north arch and render on parapet of west face of main block. (Donald Mackreth)

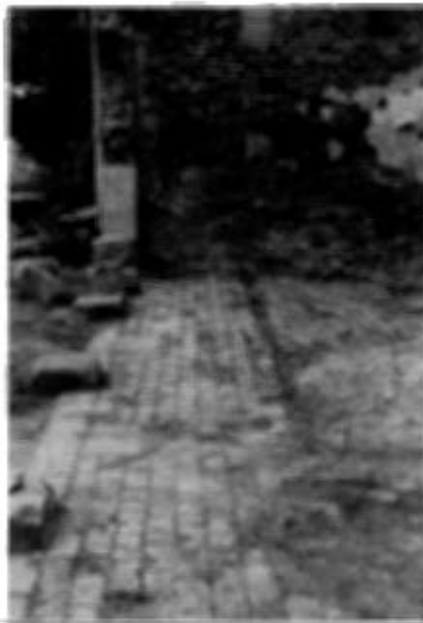
Figure 13 Brick paving revealed in view looking west of padstones of south arcade; slot in brick floor may have held partition for counter; stones set between arches possibly reduced by wear. (Donald Mackreth)

The floor of the grandstand was built of brick quarries, which had survived relatively undisturbed along with the padstones of the ground floor piers. In the middle of each arch was a stone which may have been introduced to prevent wear and tear. One interesting discovery was a slot running the length of the floor from east to west containing a very decayed piece of timber packed with Colleyweston chips. This slot may well have housed a partition for a counter (figure 13). Iron fittings in the

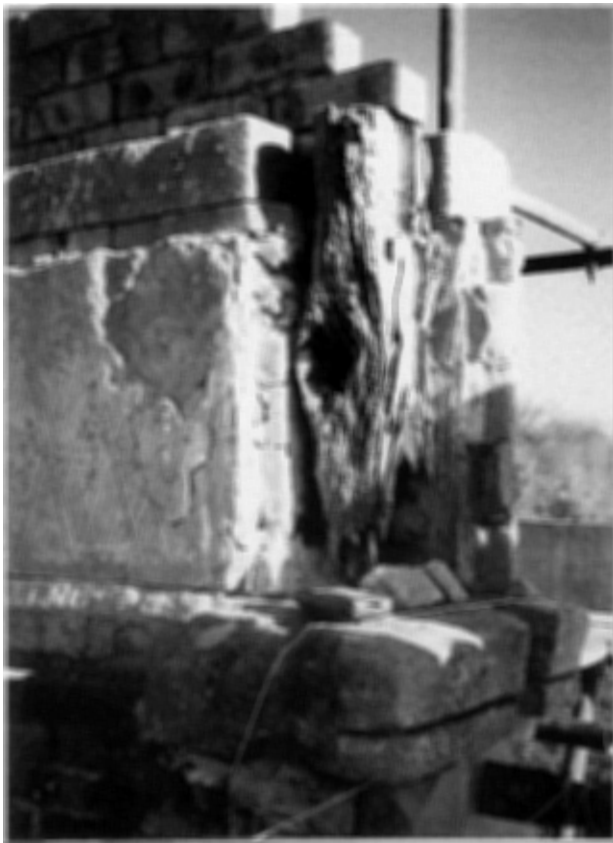
Figure 14 Wizenod timber is all that remains of the second floor roof structure, November 1995. (Author)

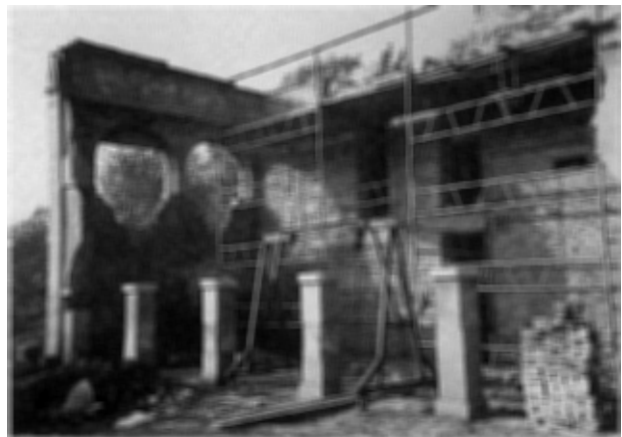
Figure 15 Rebuilding south façade, integrating old stone with new, October 1995. (Author)

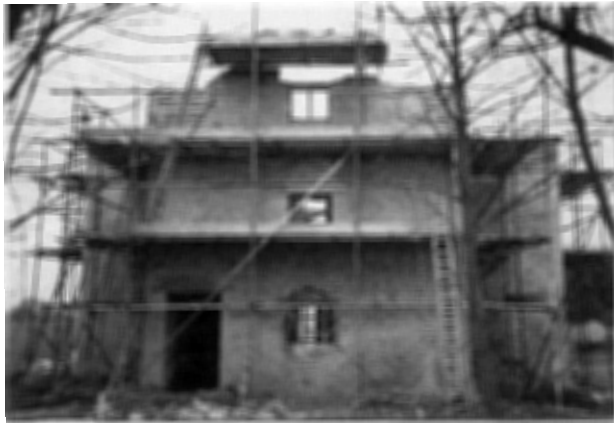
Figure 16 Stonework at rear of stand under repair, Winter 1995; timber lintel of door opening and case windows are of 1766. (Author)

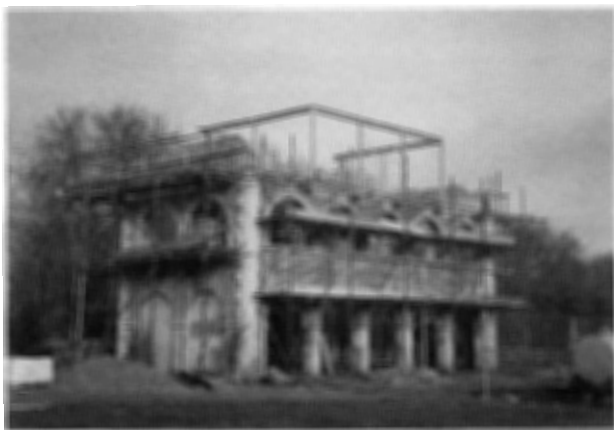
Figure 17 Upper storey under repair, Spring 1996. Steel frame for new second storey in place. (Author)

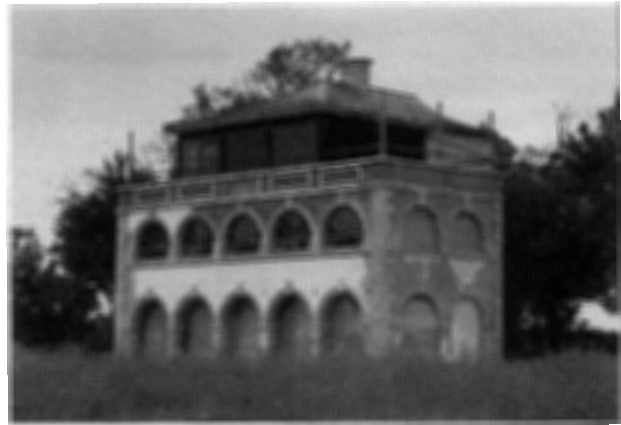
Figure 18 Coleford bricks instated in south façade being rendered; parapet being reinstated; new top storey with glazed openings in steel frame and swept copper roof constructed over timber frame, June 1996. (Author)

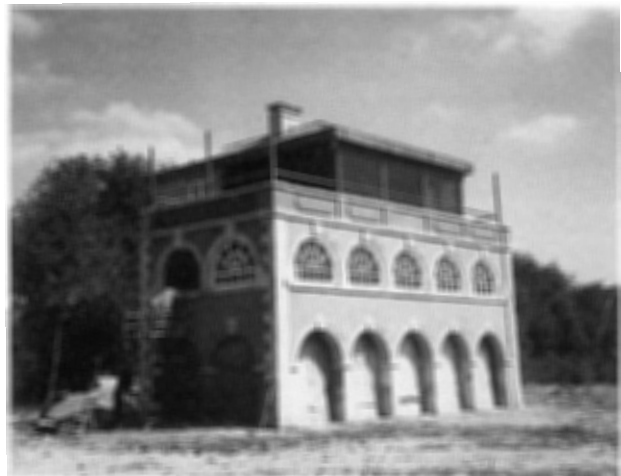
Figure 19 The render has been limewashed based on an analysis of the original ingredients, which included coppers; the newly glazed windows follow a traditional Stamford pattern; the chimney echoes a design of 1769. (Author)

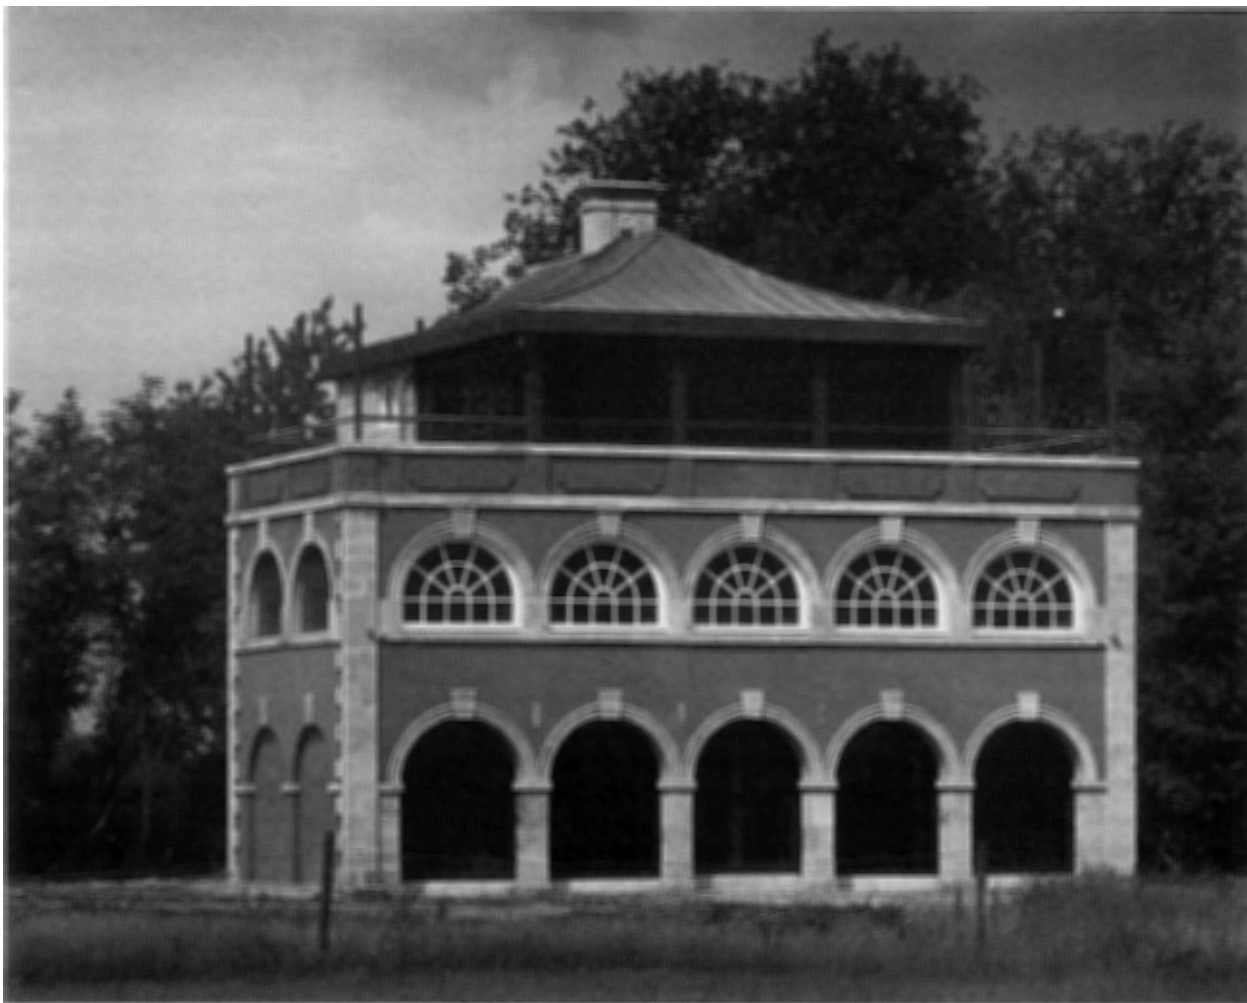
Figure 20 The Grandstand ready for sale; a recessed glazed screen at ground floor level allows the arcade to remain open. (Jackson Stops and Staff)

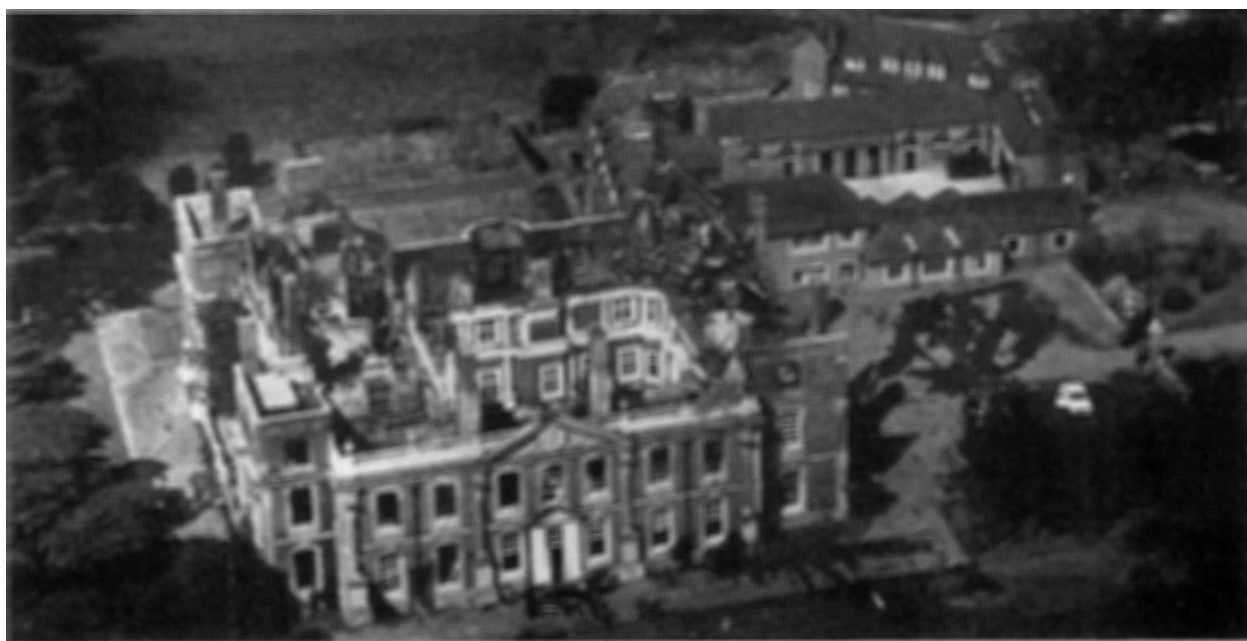
Figure 5 The morning after the 1969 fire.

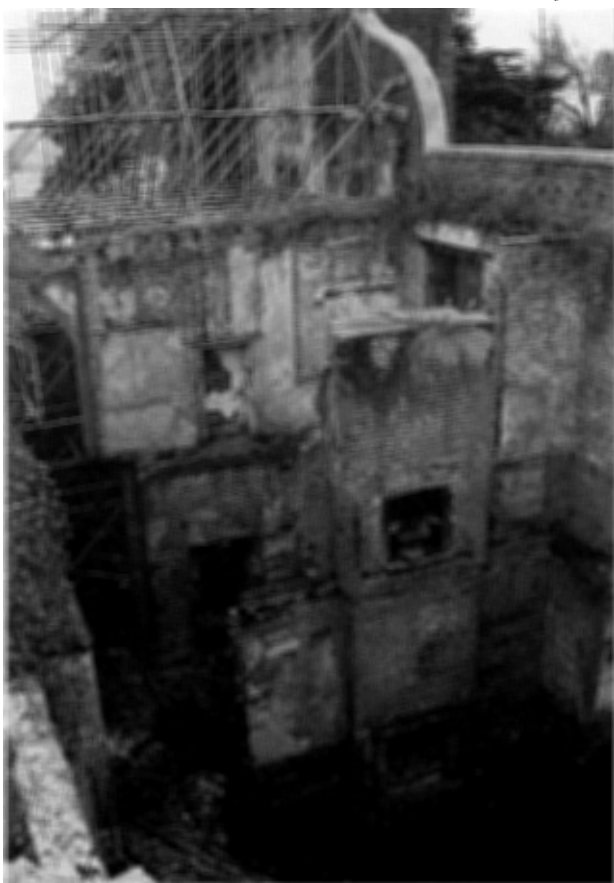
Figure 6 View over the West Range in 1993, with scaffold shoring to gable end wall of South Range.

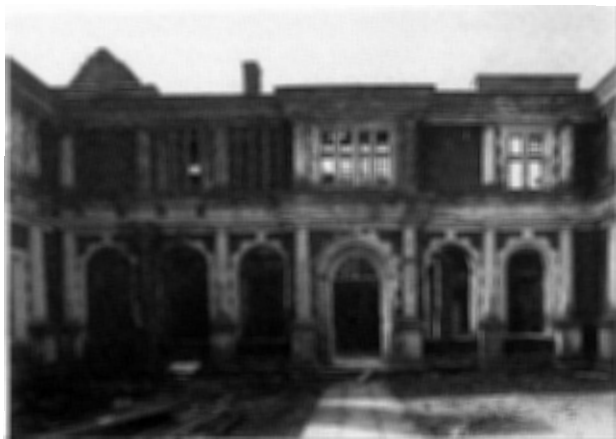
Figure 7
The South Courtyard Elevation before restoration.

Originally, the Tudor design would have had a larger central dormer on the South Elevation and further dormers on the East Elevation, but these had gone by 1714. On the ground floor, the original design had an open loggia with low brick walls, which was infilled with large sash windows around 1714. The sashes were reinstated, but painting the new windows in a dark colour has diminished their visual impact, allowing the loggia design to be read clearly. On the East Elevation, the eighteenth-century niche was also retained, as it had replaced the original central doorway when the East Range was reconstructed with a new cross wall here in 1714.

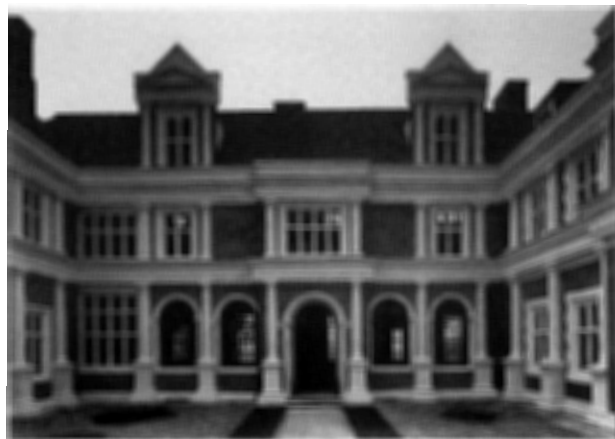
Figure 8 The South Courtyard Elevation after restoration, with new Corinthian dormers and dais window.

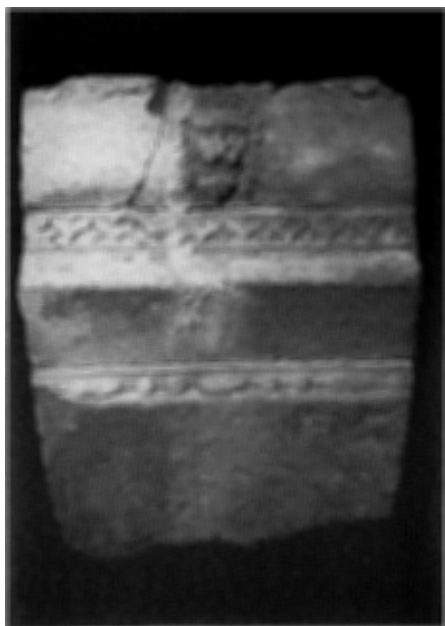
Figure 10 Finely moulded terracotta cornice block with lion mask, discovered by archaeologists. This block gave the design for the restoration of the cornice of the Corinthian dormers.

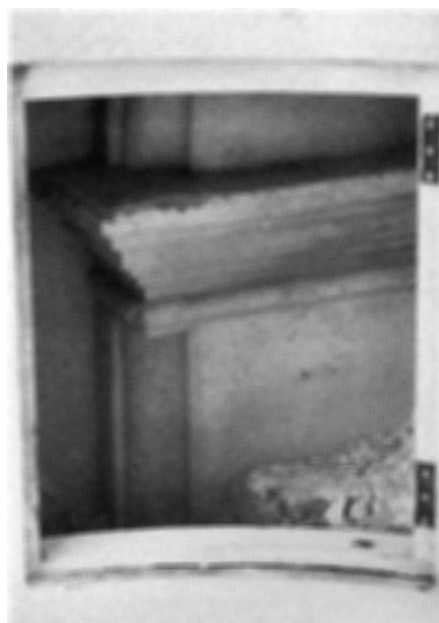
Figure 11 The original 1570s white lime plaster finish to the door jamb of the blocked East Courtyard doorway.

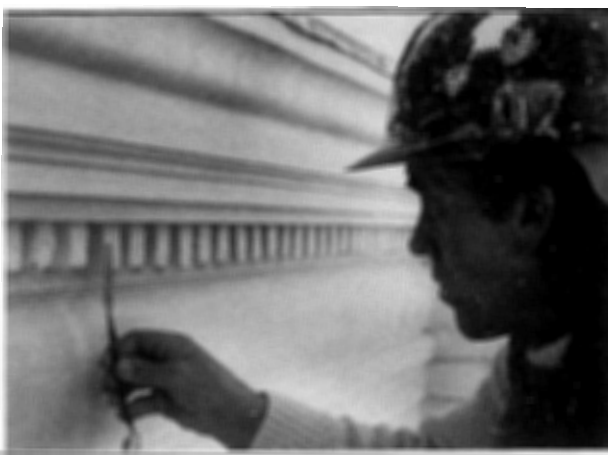
Figure 13 Hand-modelling of the lime plaster finish to dentils of the Ionic entablature.

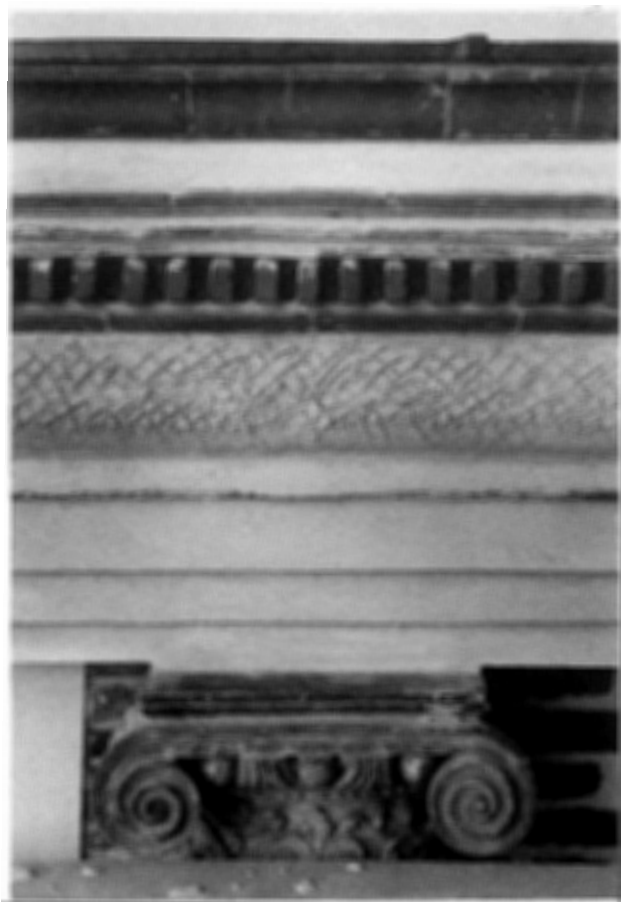
Figure 12 Detail of Ionic entablature with profiled terracotta and plaster undercoats.

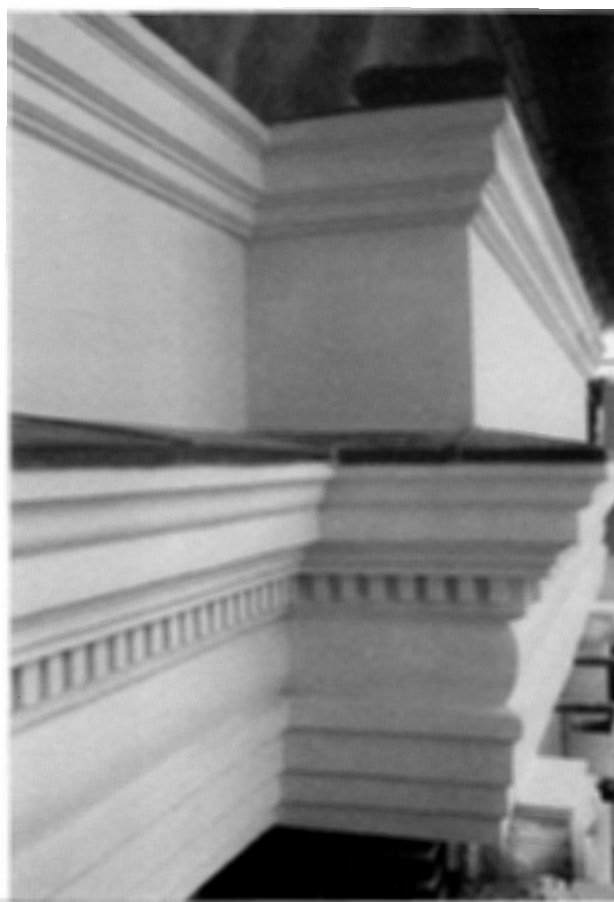
Figure 14 The fine lime plaster finish, without limewash, to the Ionic entablature.

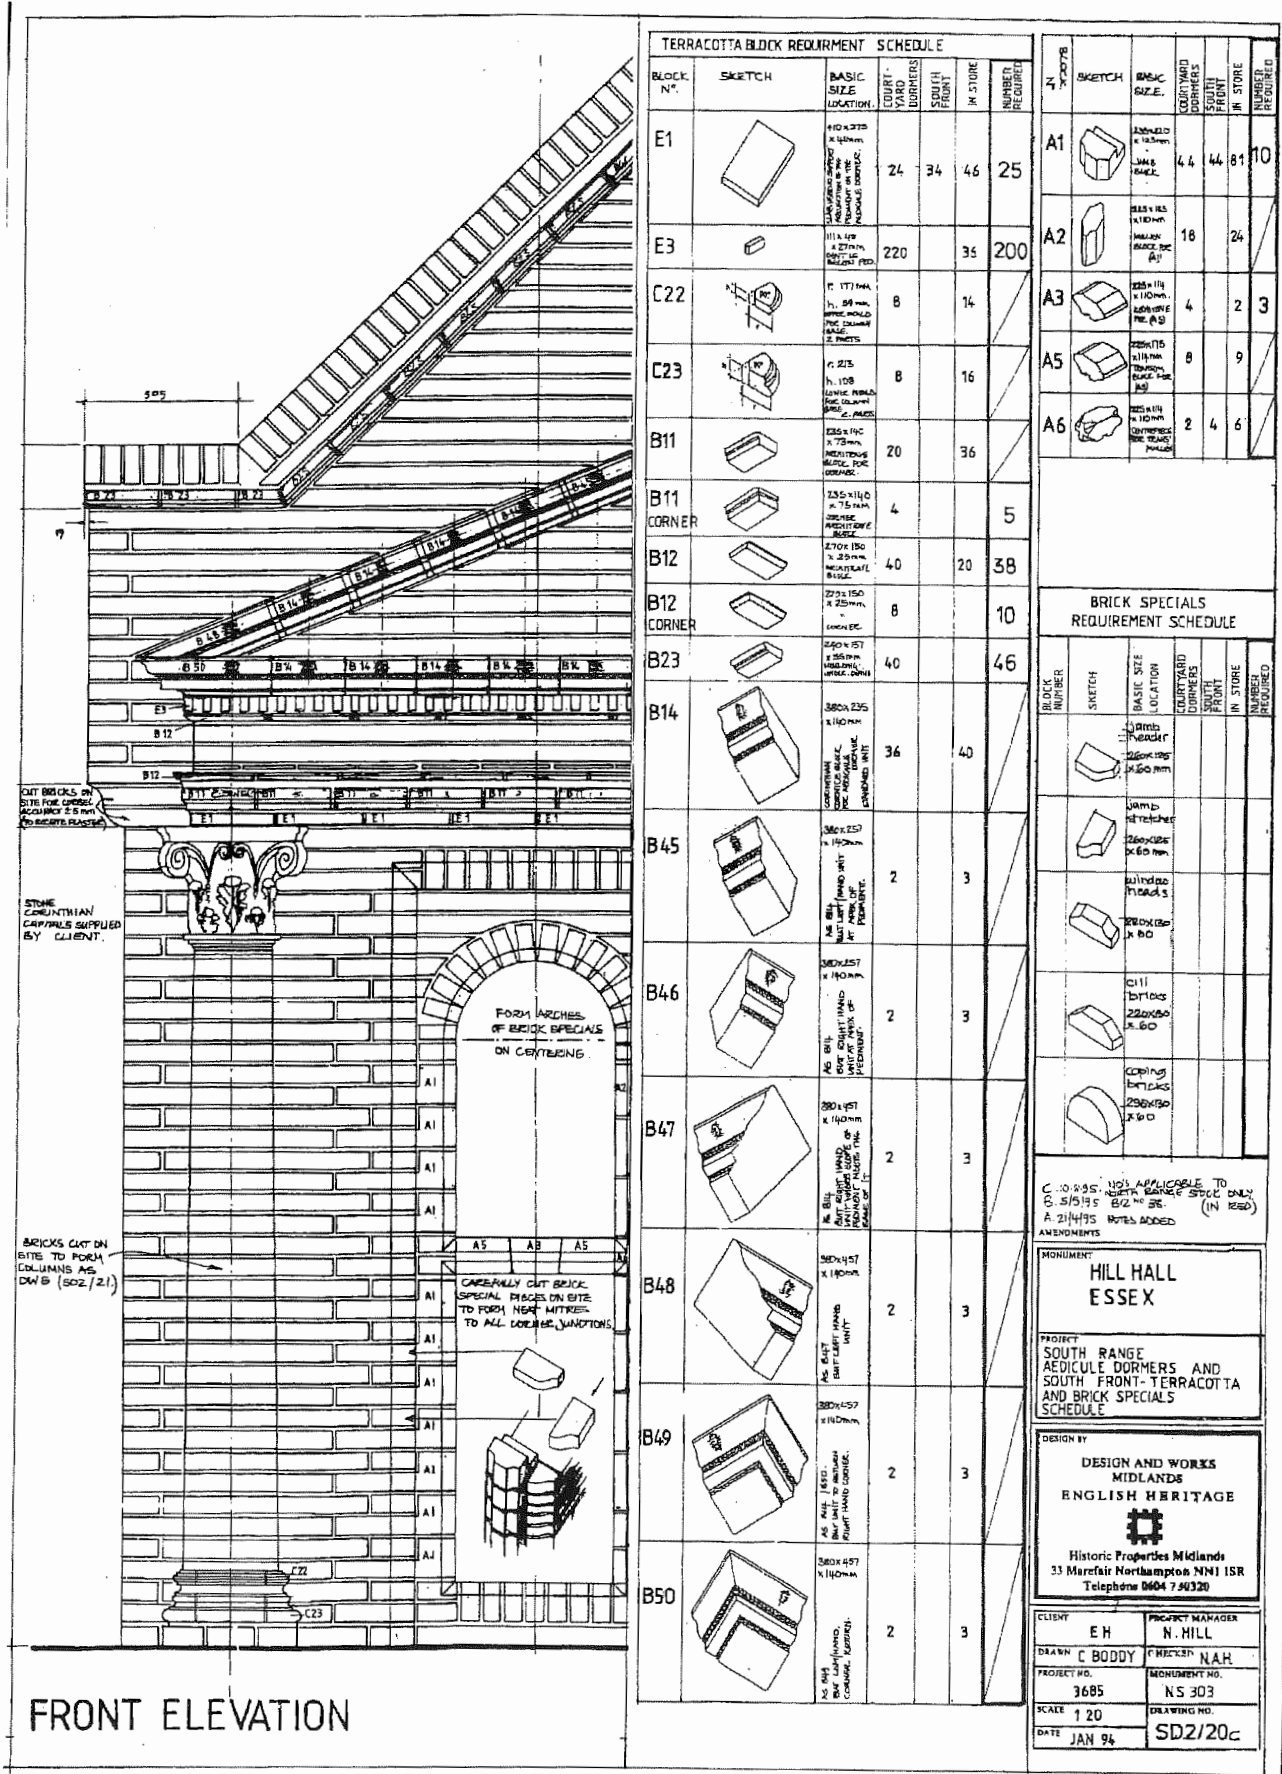
Figure 16 Design for the Corinthian dormer, with moulded terracotta schedule.

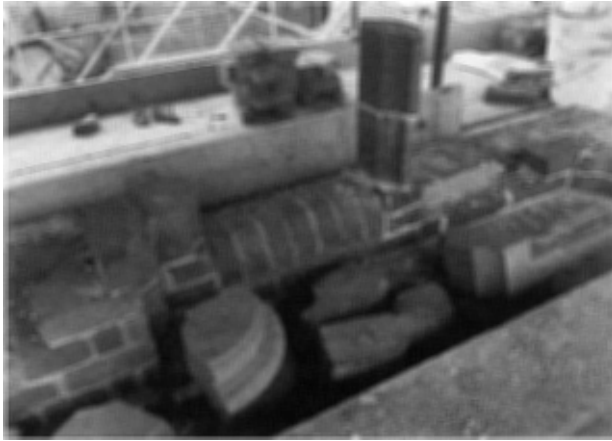
Figure 17
Setting out the base of the Corinthian dormer.

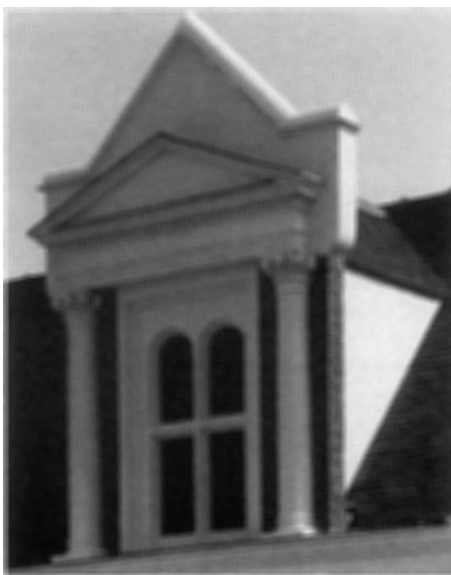
Figure 18 The Corinthian dormer with completed plaster finish.

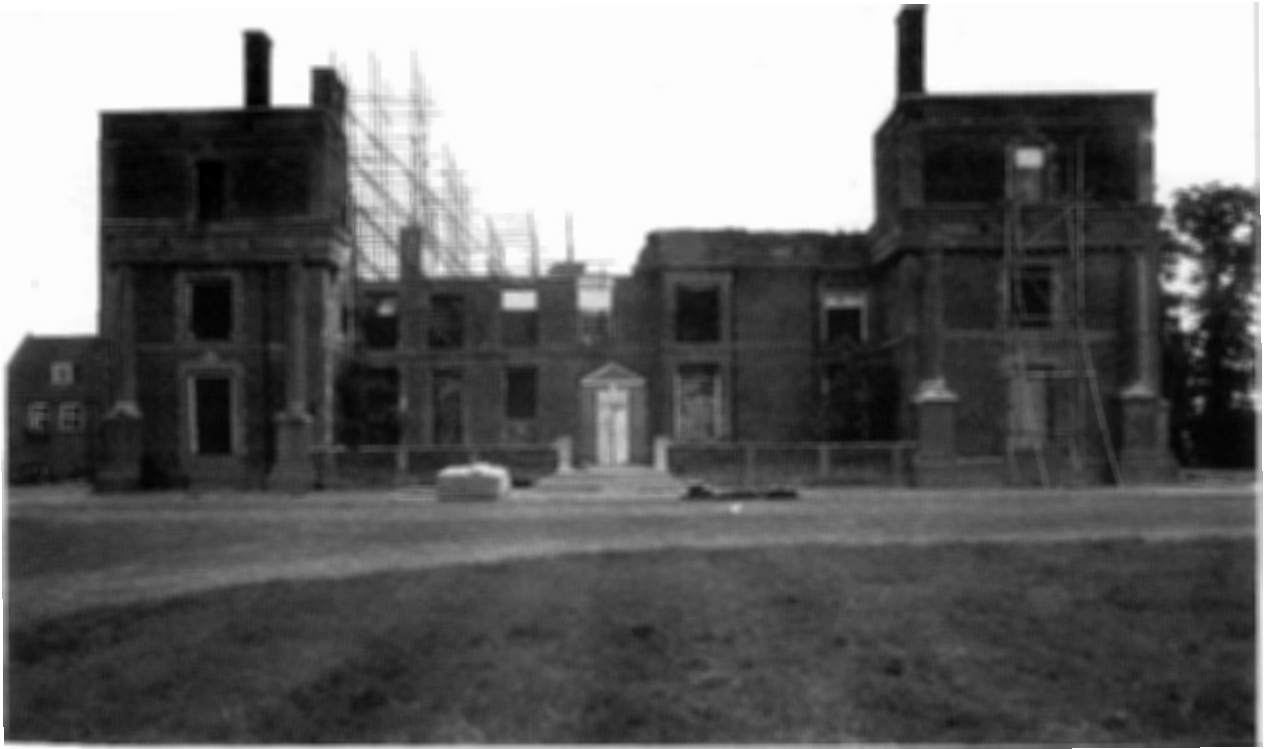
Figure 21 The South Front in 1995.

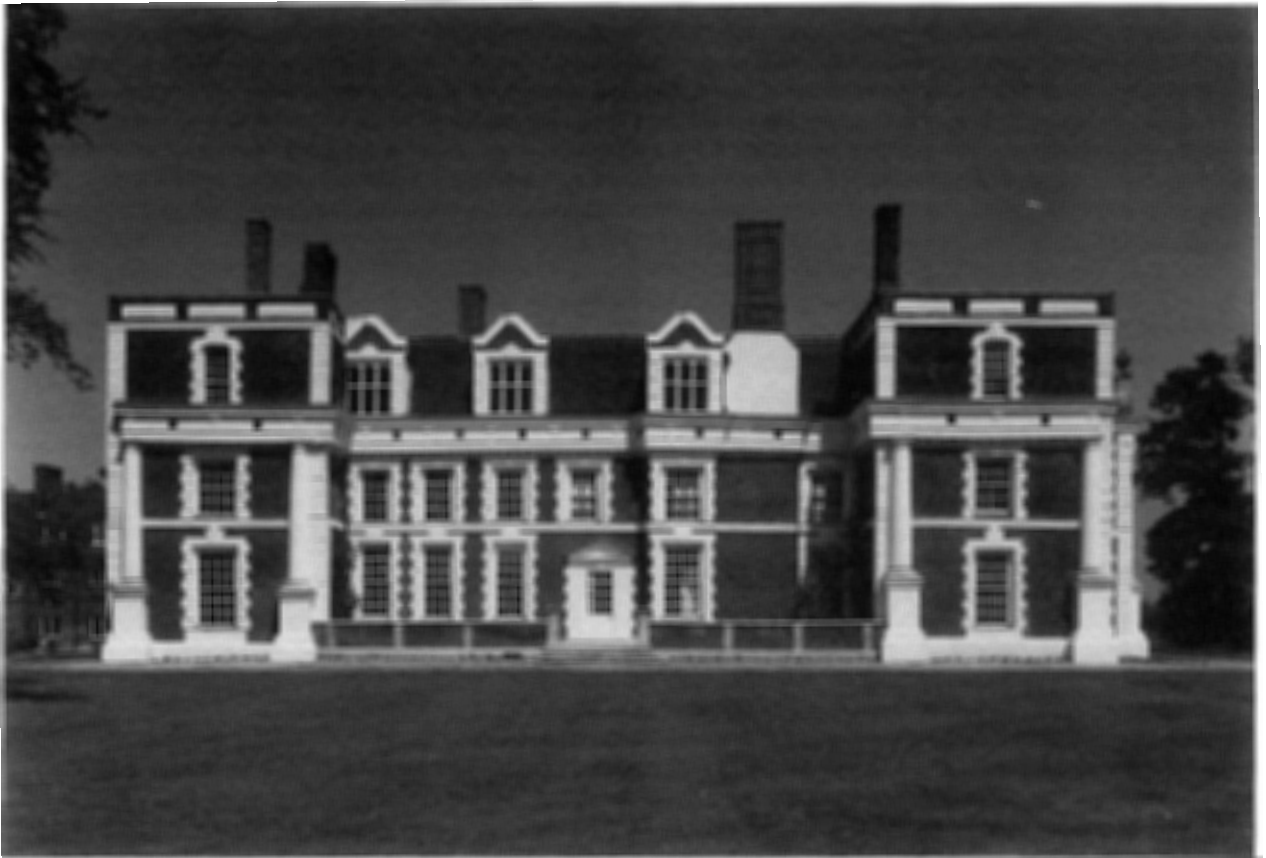
Figure 22 The South Front in 1998.

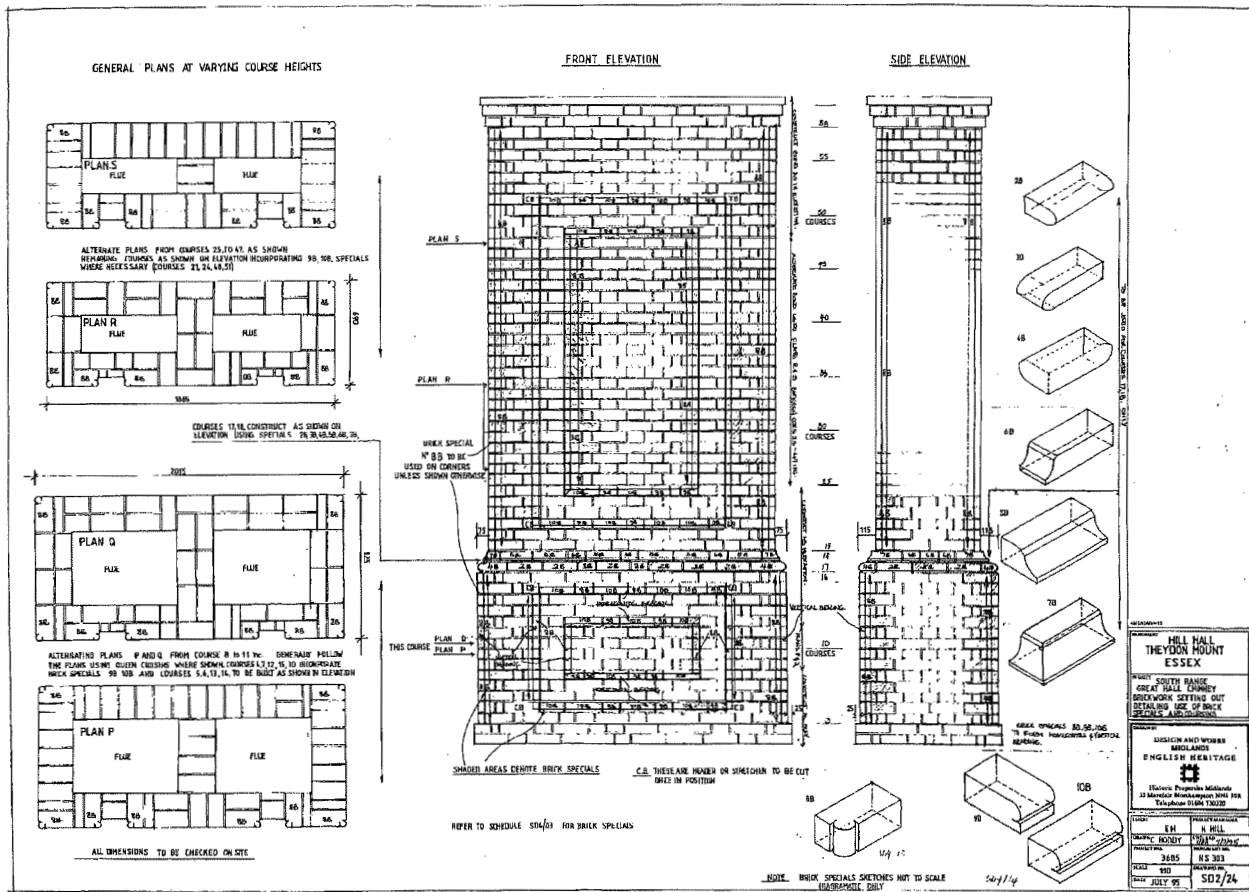
Figure 23 Design for the Great Hall chimneystack.

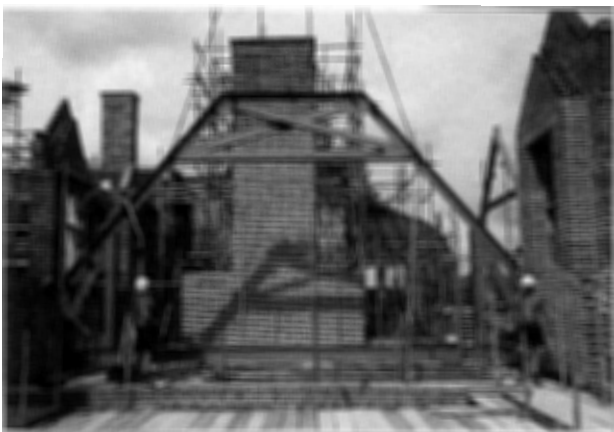
Figure 24 The first steel roof truss on the South Range being lowered into place.

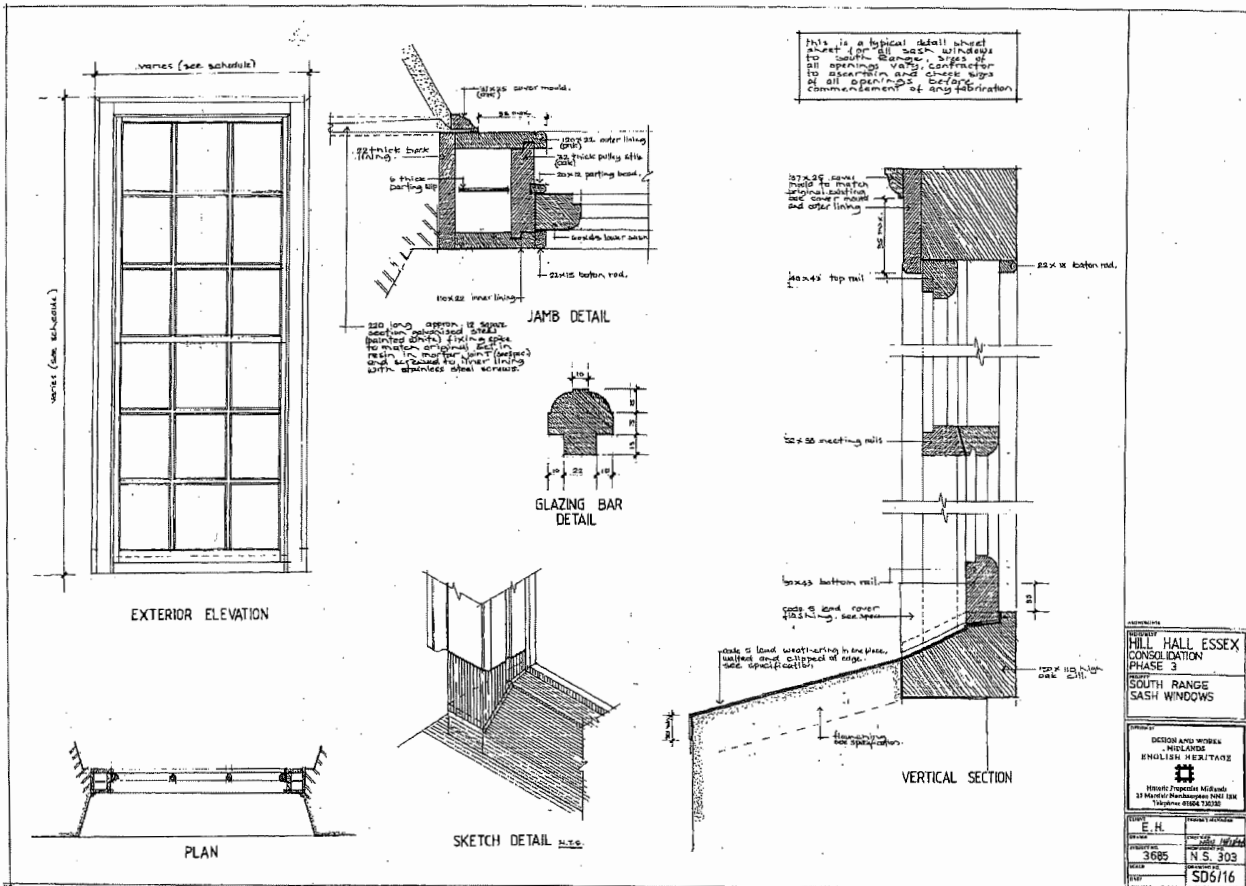
Figure 25 Design for the South Range sash windows. The unusual, awkward cill detail survived in situ, and resulted from the adaptation of the original brick mulioned window to timber sashes around 1714.

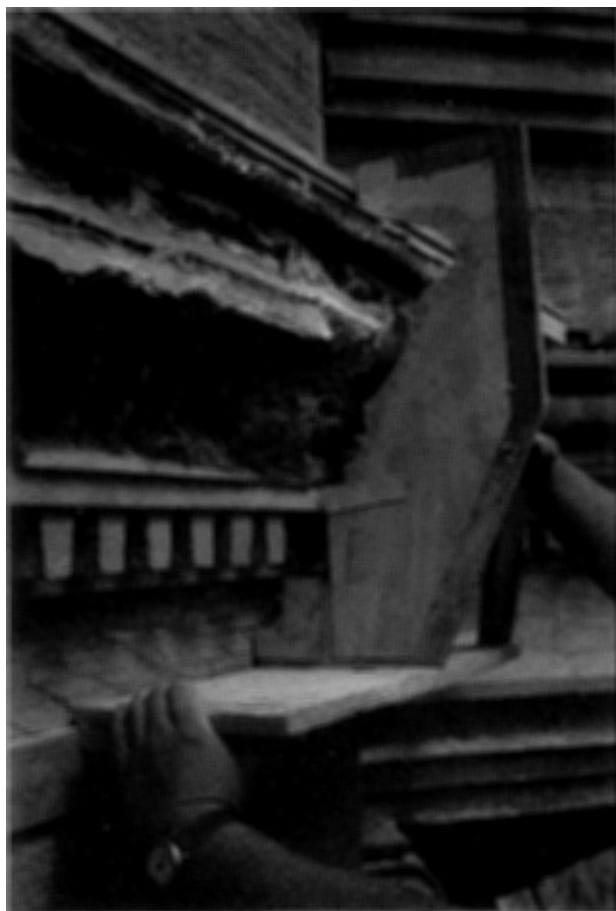
Figure 26 Cornice to West Courtyard elevation. The early-19th-century Roman cement dentils survive, but the rest of the profile needs major building up.

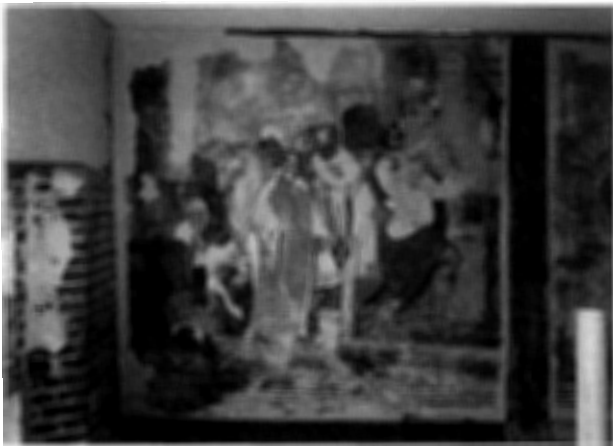
Figure 27 One of the scenes from the Hezekiah wallpainting series, after conservation.

The lengthy programme of work was a great success, with all the wallpaintings soundly conserved, colour and tone much improved, and many lost details made visible. Besides the two principal rooms, the whole of the extensive wallpainting fragments dispersed throughout the North and West ranges were consolidated. A full environmental monitoring programme was carried out for the two main rooms, and conditions brought under control by the enveloping works and installation of humidity-driven electric panel heaters. We benefitted greatly by securing continuity of treatment for the whole programme (including monitoring) by Tobit Curteis and his team over the whole five year span – not easily achieved nowadays, within the dictates of competitive tendering and tight programme constraints, but essential in such work, where only the highest conservation standards will do.

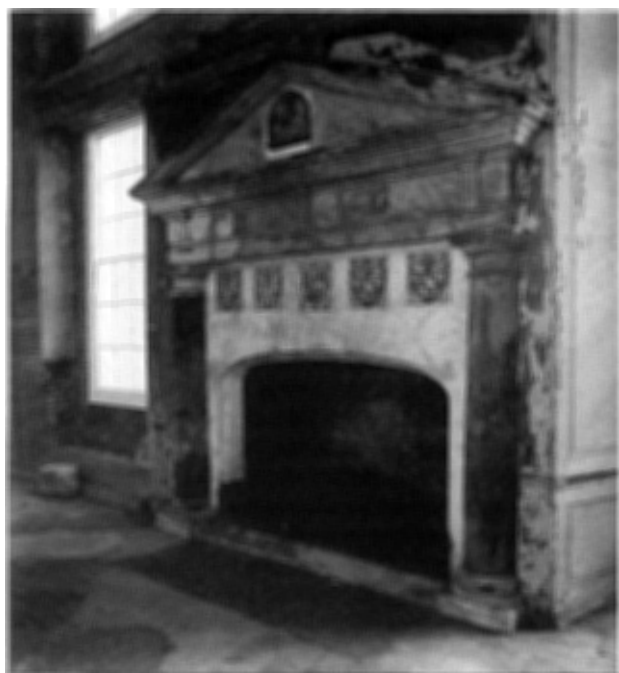
Figure 28 The Great Hall chimneypiece during conservation. The original grey plaster has been repaired on the columns with a matching mix, which is still drying out.

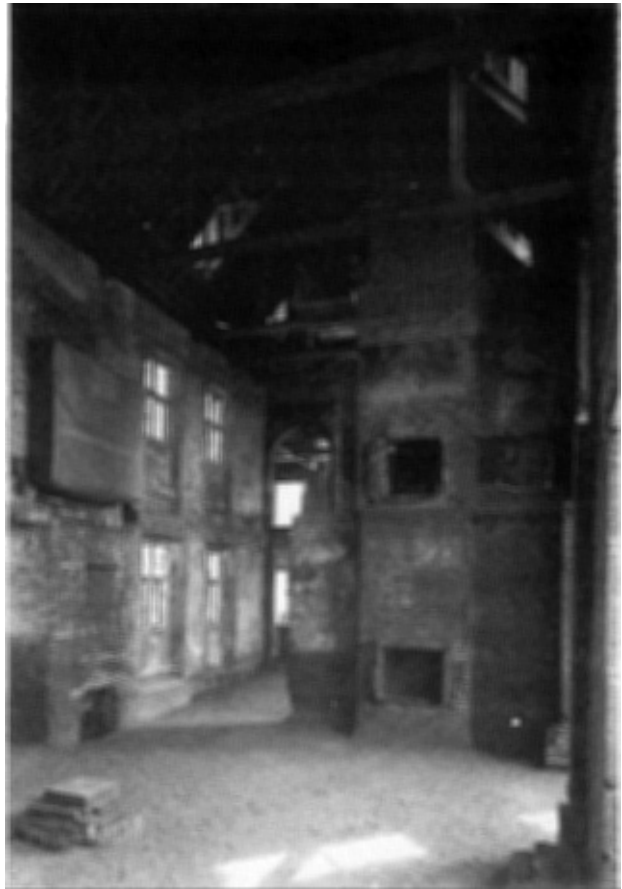
Figure 29 Interior view of the West Range after completion of the external envelope restoration. Compare with *figure 6*.
