TRANSACTIONS VOLUME 23 1998

Association for Studies in the Conservation of Historic Buildings

Conservation in Northern Ireland since 1969 by Marcus Patton OBE BSC DipArch RIBA	3
The Grandstand at Stamford: Its History, Repair and Re-use by Dr Jennifer Freeman BA(HONS) GradDiplCons(AA) IHBC	15
How we Select what to Conserve: Unlisted Buildings within Conservation Areas by Deborah Pope BA DipArch with Landscape Des pgDipArchCon & Linda Watson BSC BArch DipArchCons	25
Hill Hall, Essex: The Post-fire Restoration by Nick Hill MA BSC ARICS GradDiplCons(AA)	29
The Parthenon: A Visit by Cathy Fisher BAS BArch GradDiplCons(AA) RIBA IHBS AABC	50
Gauged Brickwork: Tracing the Netherlandish Influence by Gerard Lynch LCG CertED MA(Dist) & David Watt BSC(HONS) DipArchCons(Leic) PhD MSc FRICS IHBC	52
A Celebration of Earth Buildings of Great Britain and Ireland by Linda Watson BSC BArch DipArchCons	67

THE GRANDSTAND AT STAMFORD: ITS HISTORY, REPAIR AND RE-USE

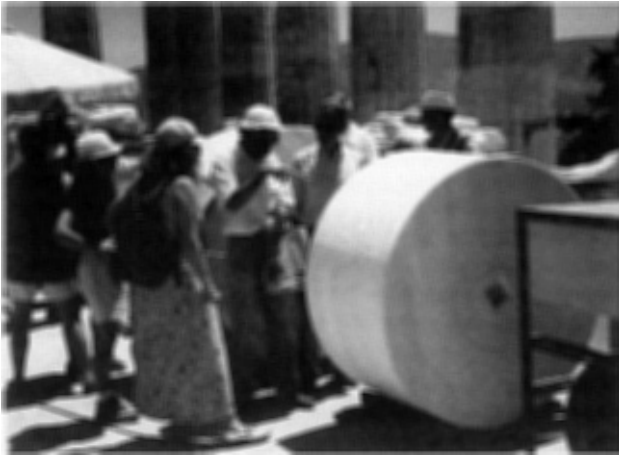
Figure 2 Dr Korres discussing a new marble column drum with the job architect

'... to correct the position of stones restored earlier, and to carry out a supplementary restoration in certain areas, using mainly the *disiecta membra* lying on the ground ...' This starts to really address the most difficult of issues. We were confused initially by the proposals of 'reconstruction'. However, having read about it in more detail, it is clearer that the intention is primarily to *re-assemble*, rather than *reconstruct* certain areas of the Parthenon. This ambitious task has been made possible after an extraordinarily detailed archaeological survey of all the scattered pieces of stone lying around the Acropolis, and an equally intensive recording of the existing standing structure of the Parthenon. It is with this background information that the 'supplementary restoration' work to certain areas of the Parthenon will take place (figure 2). The proposals are to restore the *pronaos*, using the surviving stone blocks.

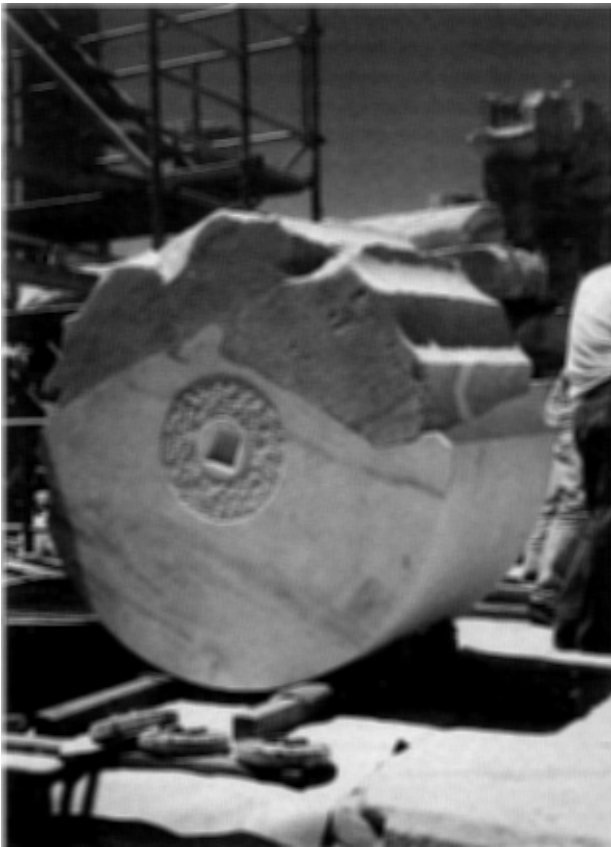
Figure 3 Restoration of lost stone to a column drum, before cutting of flutes. The new marble will be toned down to harmonise with the appearance of the original, though still readily distinguishable.

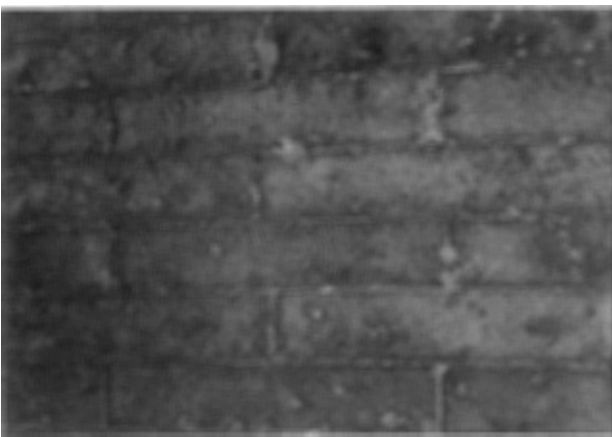
Figure 1 Herringbone tool marks from post-fired finishing on bricks at Santa Maria Della Scala, Siena, Italy. Note the fineness of the joints, made possible by the 'ashlaring' of the bricks to sharp arrises.

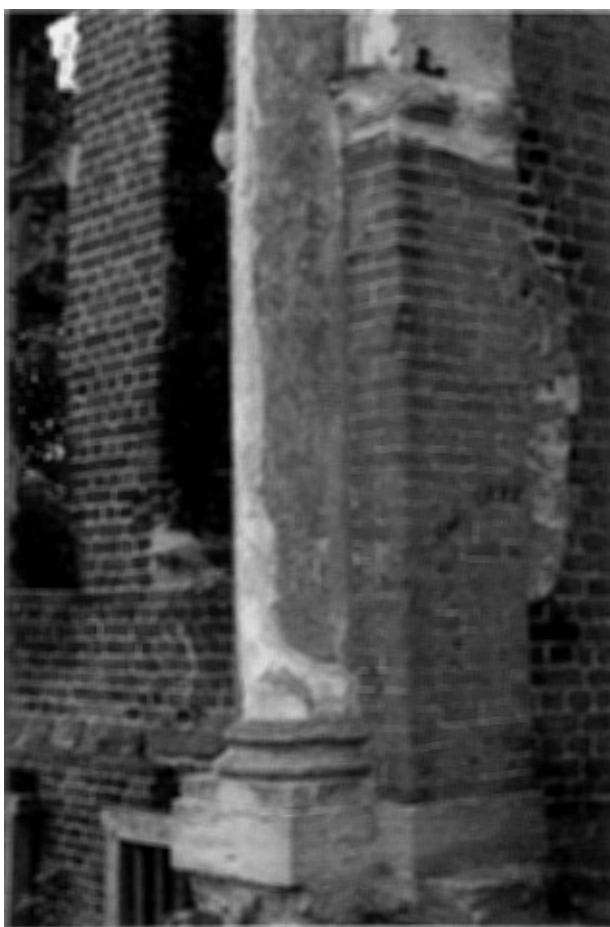
Figure 2 Part of the early gauged brickwork at Houghton House, Ampthill. This gauged work is part of a Renaissance-styled alteration attributed to Inigo Jones.

A good example of very early English gauged work is to be seen in the remains of the classical entrance porch to the north-facing elevation of the ruined Houghton House, Ampthill, Bedfordshire (*figure 2*). The ashlar gauged work of orange fine-textured rubbers is, as yet, undated, but possibly c. 1617–18 and thought to be to the designs of Inigo Jones (1573–1652) commissioned after the house was completed in 1615. Of Houghton Hall, Harris and Higgott record:²⁰

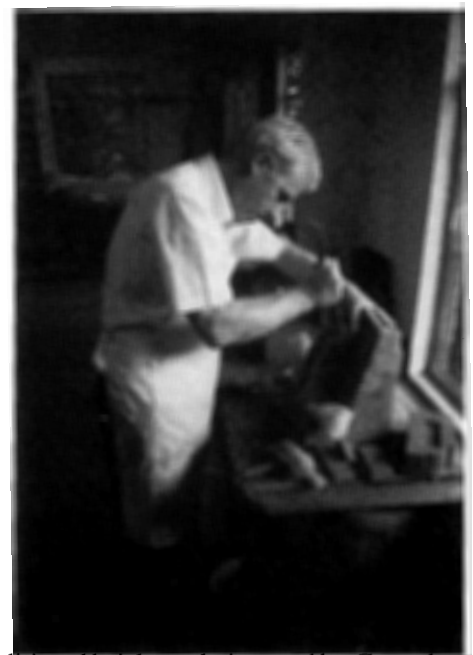
Figure 3 A traditional brick-axe being used by Gerard Lynch to cut an ornate moulding on a low-fired hand-made brick held on the chopping block in the manner of a seventeenth-century brick mason 'hewer'.

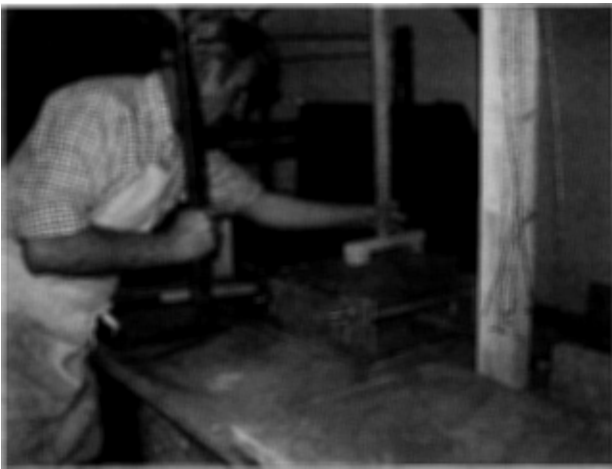
Figure 4 A twisted-wire bow-saw being used by Gerard Lynch to cut rubbing bricks held in a cutting box in the traditional manner of the late Victorian cutter.

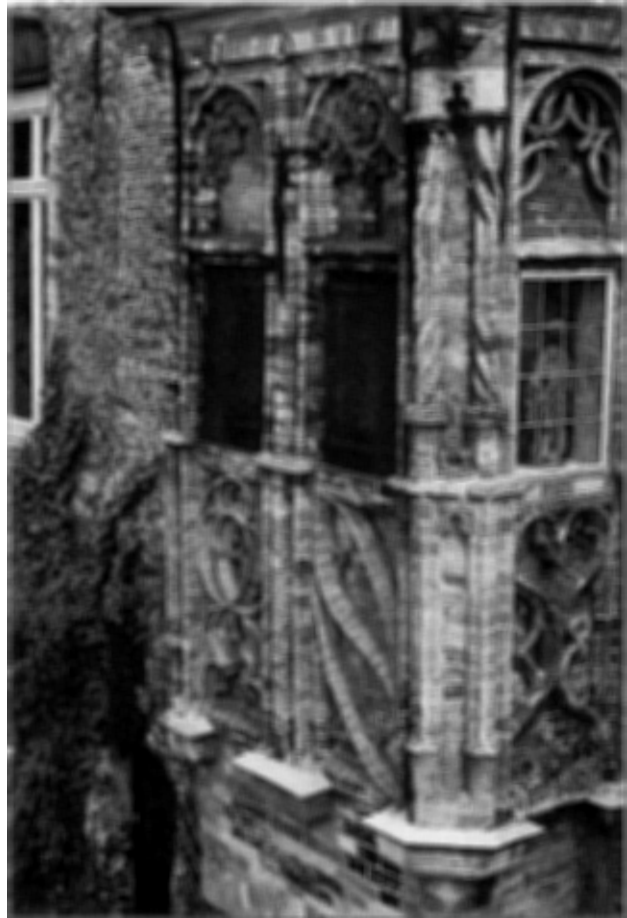
Figure 5 Wonderful early Flemish decorative gauged brickwork at Tribune Hereman van Outvelde, Brugge.

Tribune Hereman van Outvelde (1516) is a fine brick-built square-bayed window, constructed for the owner of that name, a master silversmith, intending to impress customers and display the wealth created from his craft (figure 5). The bay has many fine elements of brickwork laid as tracery and other forms of enrichment in a delightful red brick set with fine joints of 2–4 mm. This has to be considered an example of early gauged work. There are specially moulded bricks as terminal features for highly-decorated cut and rubbed quoins containing narrow flues, because in this room Outevelde smelted the ores and the flues were necessary to vent the resultant noxious fumes.

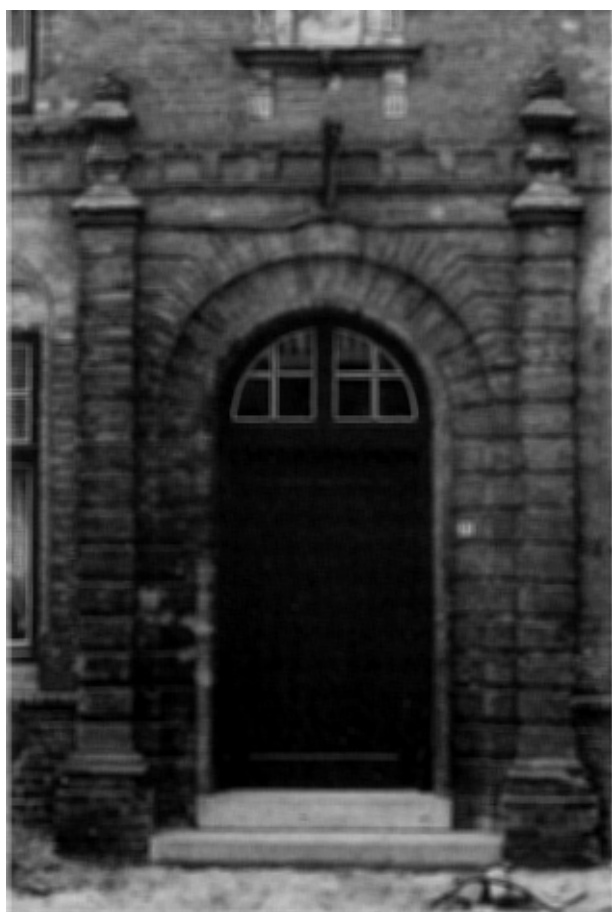
Figure 6 Fine gauged brickwork doorway, built of stone-like buff-coloured coastal bricks, at 71 Gasthuisstraat, Poperinge.

Poperinge, a former Hanse town, virtually escaped the bomb damage of the First World War that destroyed so many historic buildings in West Flanders. 71 Gasthuisstraat (1579) is constructed of English-cross (or Dutch) bond laid with mortar joints of 5–10 mm. The brickwork is of pale-buff coloured coastal bricks that are of a relatively fine calcareous body. The large central brick doorway, designed in the regional Renaissance style, is a fine example of gauged brickwork (figure 6). The same bricks are used for the main walling, but the whole manner of the doorway treatment is completely different – cut and shaped with great care and then laid with joints of 1–2 mm and cross-joints varying from 1 to 5 mm.

It may also be noted that this gauged work had been finished *in situ*, similar to the dressing of stone with a drag by a stonemason. This is known in Flanders as 'planing.' There is, however, a noticeable difference in these striations to those on the Cloth Hall in Brugge. More care has been taken to work them parallel and vertical to the jambs, and then to follow the curve of the arch keeping with the coved horizontal rustications up the pilasters framing the doorway. This feature only deviates when the direction needs to follow the radiating voussoirs.

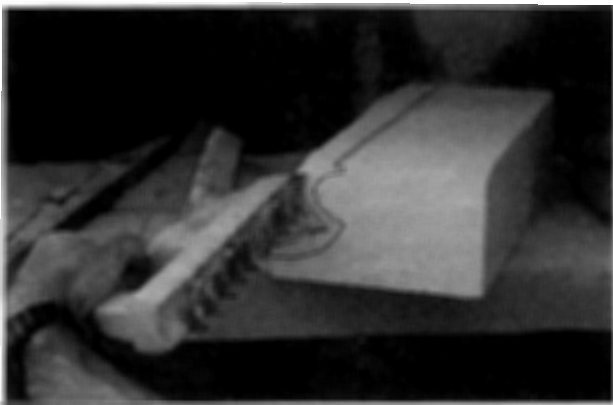
Figure 8 A steenschaaf, with appropriately-curved blades, being offered up to the lines set out on a prepared block of Le Pine limestone prior to planing the moulding.

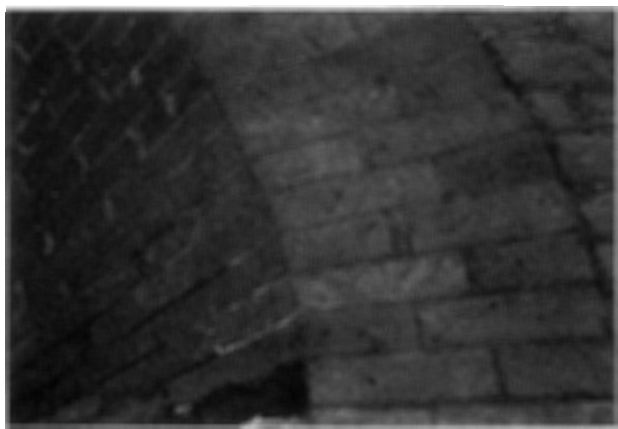
In complete contrast is the treatment of the large semi-circular arch of similar span to the church at 64 Breestraats (1635), finished *in situ* with a steenschaaf and following neatly the curve of the arch (figure 9). 9 Pieters Kirk Gracht (1620) displays gauged work for ashlar, as well as handsome segmental arches. This, again, was finished *in situ* with the steenschaaf, being highly suggestive of Flemish craftsmanship and craft practices.

Figure 9 Detail from the face of the large-span, canted semi-circular gauged arch at 64 Breestraats, Leiden, showing striations made by the use of the steenschaaf.

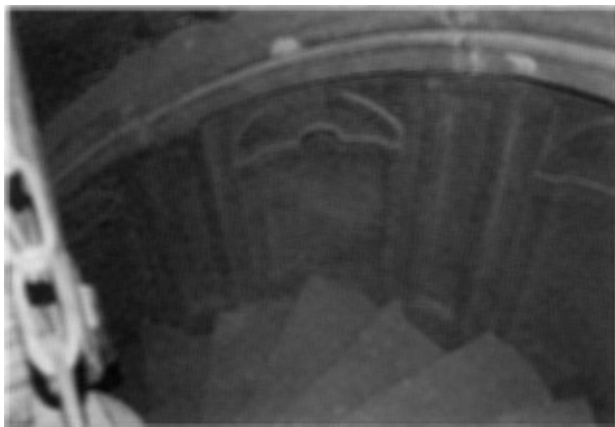
The bricklayers placed their masterpieces, all executed in gauged work, around the walls of De Waag. These are dated from the second quarter of the seventeenth century, up to about 1670, and are part of the classical and more theoretical approach that was sweeping Dutch architecture in the early seventeenth century, deriving its heritage from the Renaissance and the classical proportions of the orders. Almost all of the original medieval wall surfaces of the guild room and spiral staircase are decorated with more than eighty masterpieces of very artistic gauged brickwork (*figure 10*). This is similar to the best English gauged work in all

Figure 10 A section of the seventeenth-century gauged brickwork masterpieces in De Waag, Amsterdam, that follow the spiral staircase to the top of the entrance tower in De Waag, Amsterdam.

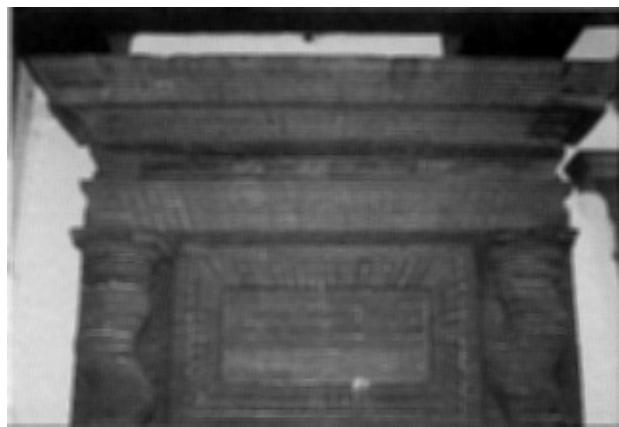
The premier example to all of this brick craftsmanship is just inside the door of the payment room for the guild. A beautiful niche, with a carved scallop-shelled boss, is surmounted by a richly moulded pediment carried at each end by two turned columns on the capitals of which is carved the inscription 'Anno 1660' (*figure 11*). This confirms the high level of perfection that such work had reached in the Netherlands before the Great Fire of London of 1666.

Figure 11 The exquisite seventeenth-century gauged brickwork masterpiece in De Waag, Amsterdam. The date of construction is clearly carved into the capitals 'Anno' and '1660'.
